OPN Architects, Inc. + Simpson Gumpertz & Heger Inc. + Modus Engineering + Shuck-Britson, Inc.

January 2016 Capitol Dome Report

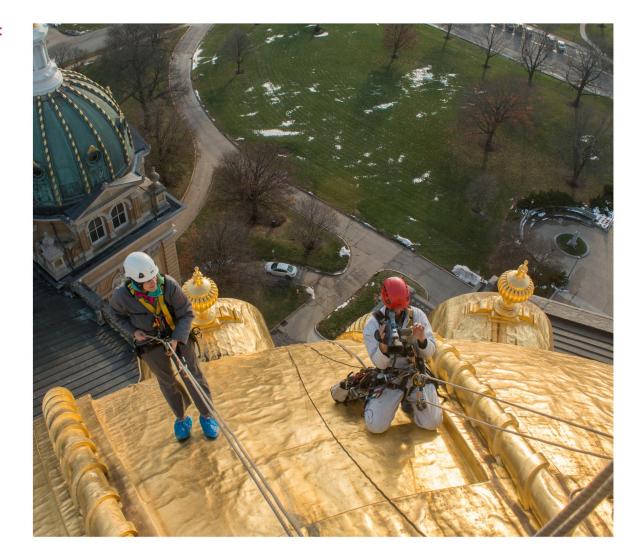
- Address bulk leakage at the observation level
- Address condensation at the lantern level
- Perform repairs to the copper sheet metal:
 - Lantern Level
 - Main Dome Levels
 - Stylobate Roof Level
- Address water leakage at the windows
- Repair masonry on the interior dome and drum
- Point masonry joints
- Remove and replace sealant
- Repair and repaint wood windows
- Resurface delaminated sandstone in situ

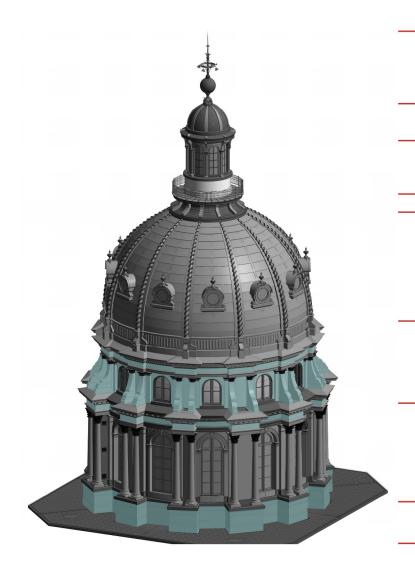
- Point masonry joints
- Remove and replace sealant
- Resurface delaminated sandstone in situ
