## CAPITOL DOME STUDY FOR THE STATE OF IOWA

OPN Architects, Inc. + Simpson Gumpertz & Heger Inc. + Vertical Access LLC + Shuck-Britson, Inc.

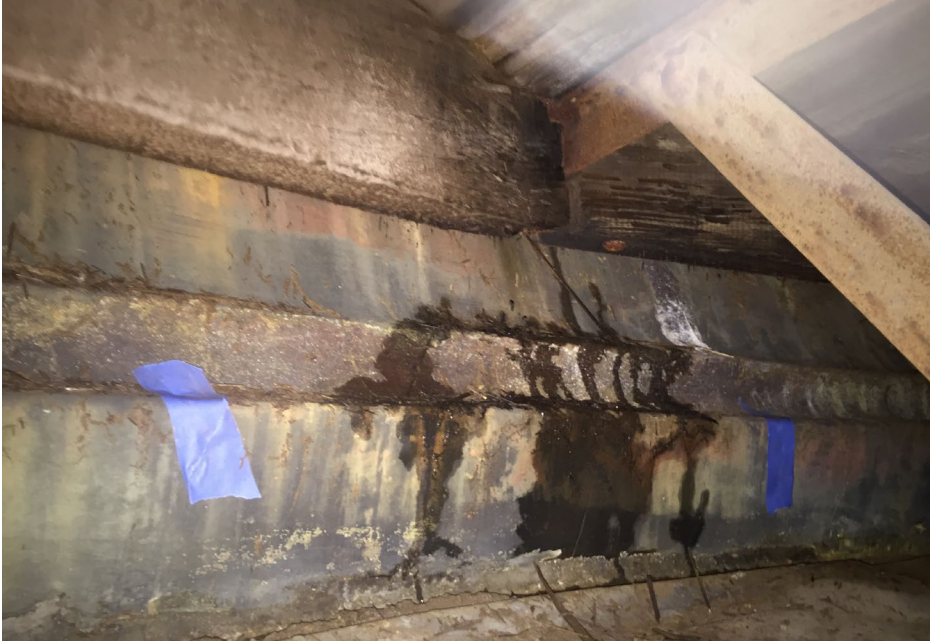
- Prior to full team arrival at the site on November 17, 2015 while during a light rain, OPN accessed the dome attic and observed leakage at two locations under the projecting cornice (Photo 5)

**Photo 5** Leakage observed below lantern dome cornice during a rainstorm.

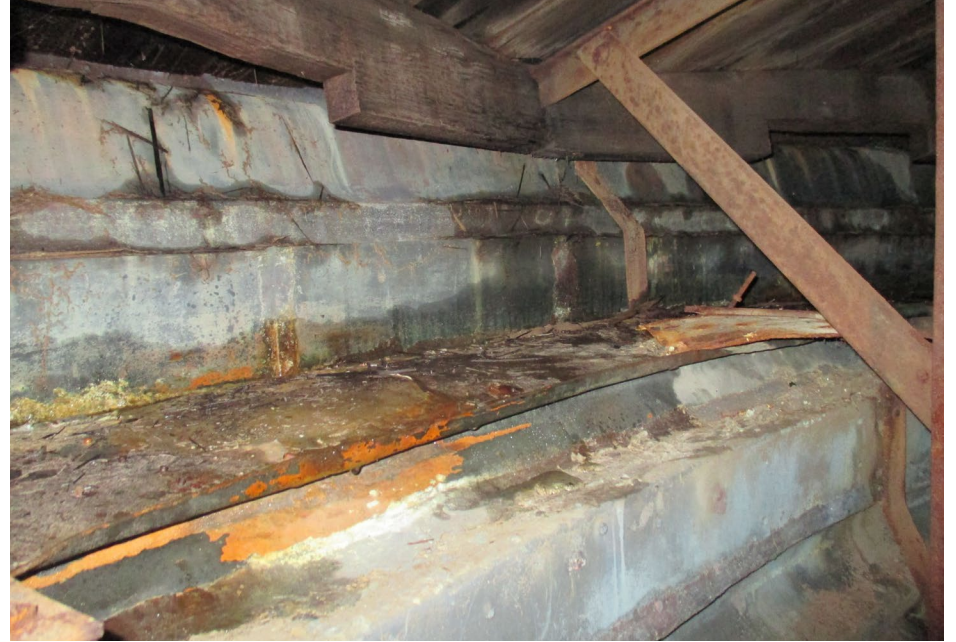
**Photo 6** Condensation accumulation in the lantern dome soffit.

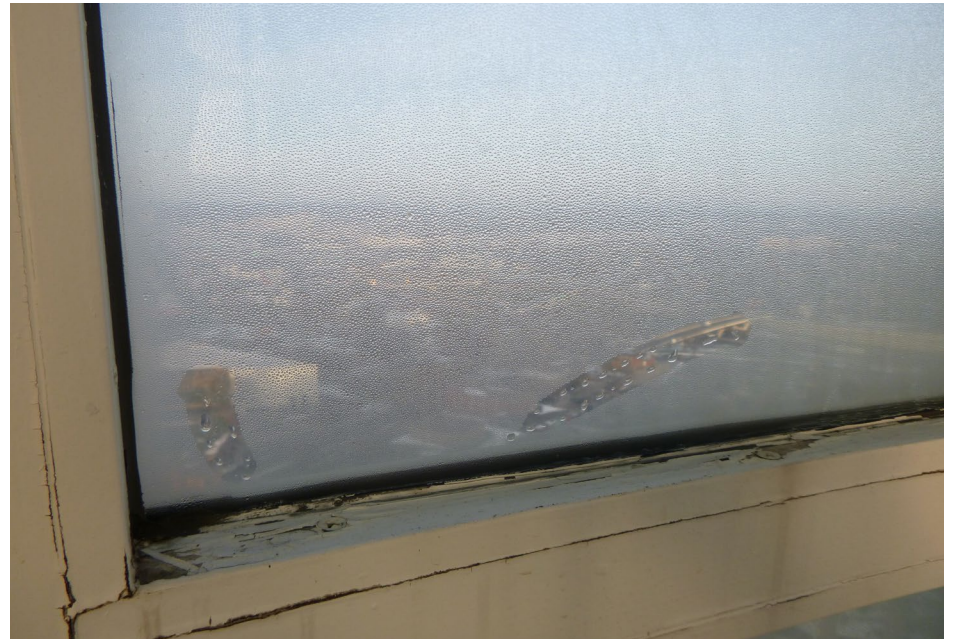
- We observed condensation on interior face of the lantern window glazing (Photos 8 and 9). Wood finishes around the windows are water stained, particularly at horizontal mid-rails (Photo 10) and the base of the windows (Photo 11).
- Lantern glazing is single pane glass. The 1997 Phase 9 restoration drawings provided for new windows. The use of

**Photo 9** Lantern window condensation.

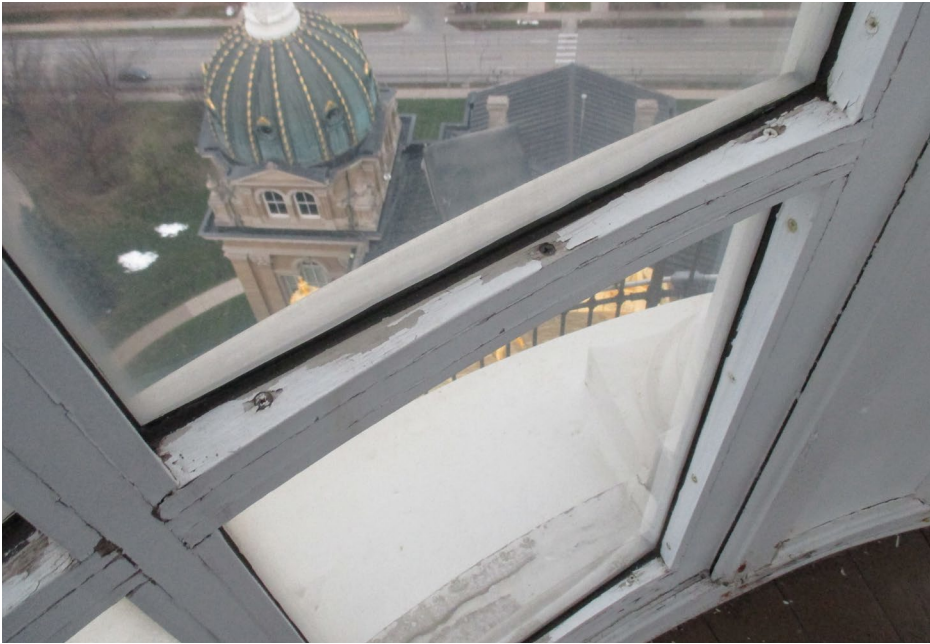
**Photo 10** Deteriorated wood at lantern window midrail.

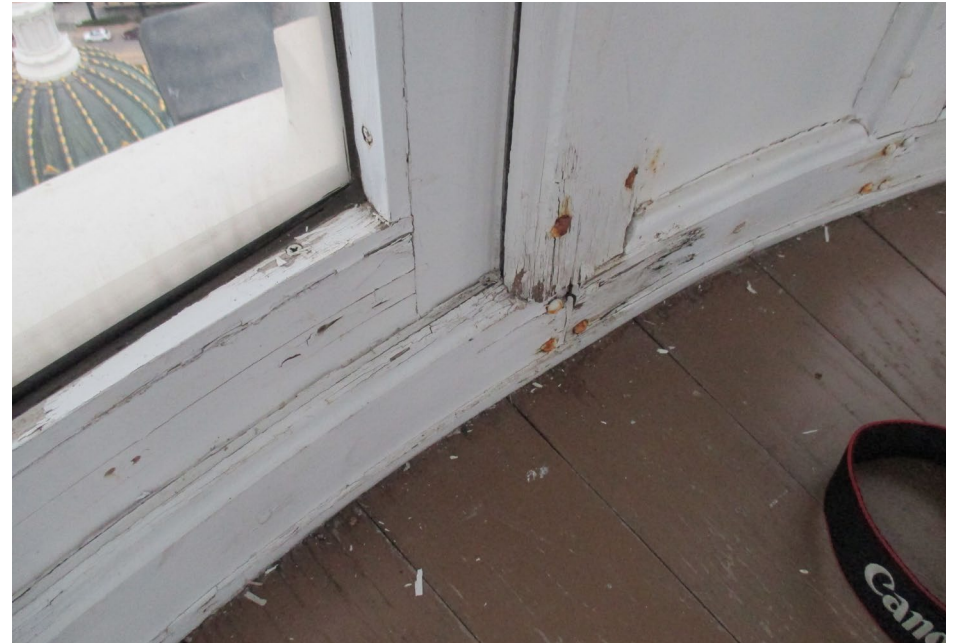
**Photo 11** Typical failing paint, deteriorated wood & corroding fasteners at lantern window sill.

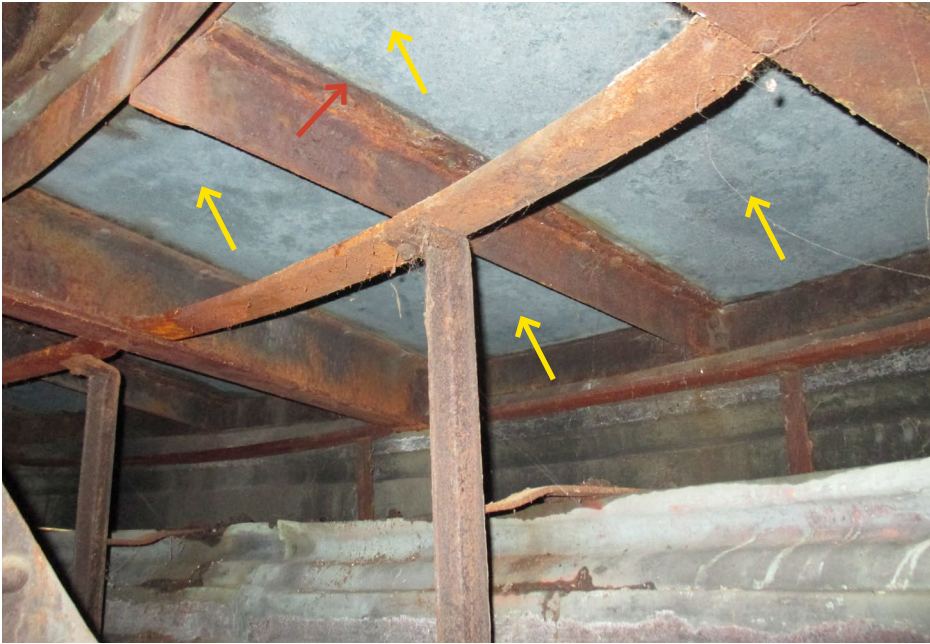
- The metal framing members supporting the lantern observation deck have varying stages of corrosion (Photo 14). Framing members directly below the observation deck are particularly corroded, with some members having nearly an inch of rust scale built up under the observation deck planks (Photo 14). We observed condensation on the underside of the dome's sheet metal roofing (Photo 15). Similar to the attic dome condensation, we are certain this moisture is condensation related, as we observed moisture several days after the most recent rain/snow event; we also noted frost/ice when observed early on a cold morning.

**Photo 14** Framing below observation deck planks (yellow arrows) is corroded; note built-up rust scale at WT member directly below planks (red arrow).

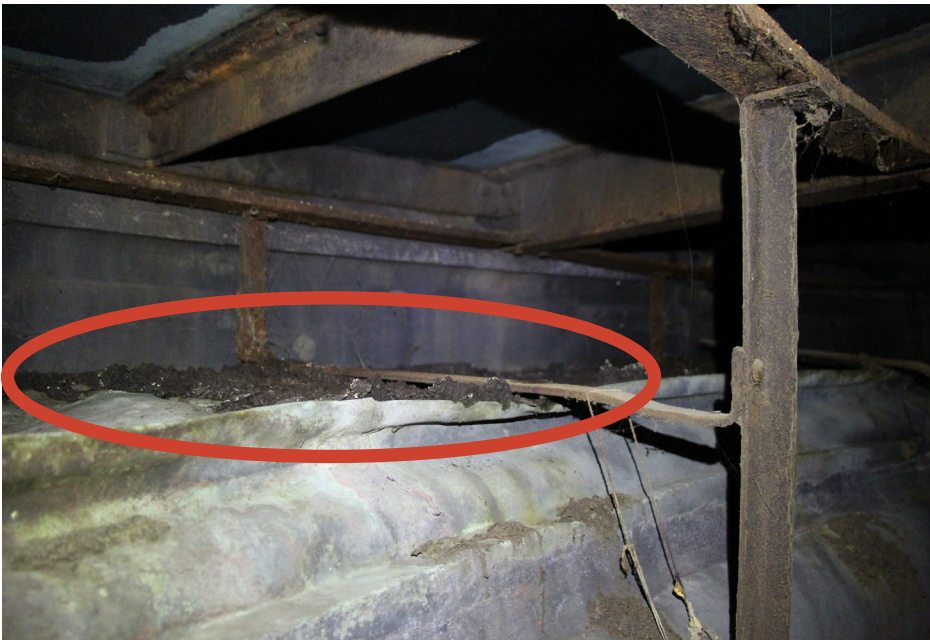
- We observed daylight shining through perforations or openings in the roof within the attic at several locations, most regularly near the exterior edge of the observation deck. Similar to the lantern dome roof, the sheet metal cladding has an overhanging profile that forms a horizontal "pan" below the observation deck. This "pan" is filled with wet debris (Photo 16).

**Photo 16** Wet and debris-filled soffit within the lantern attic.

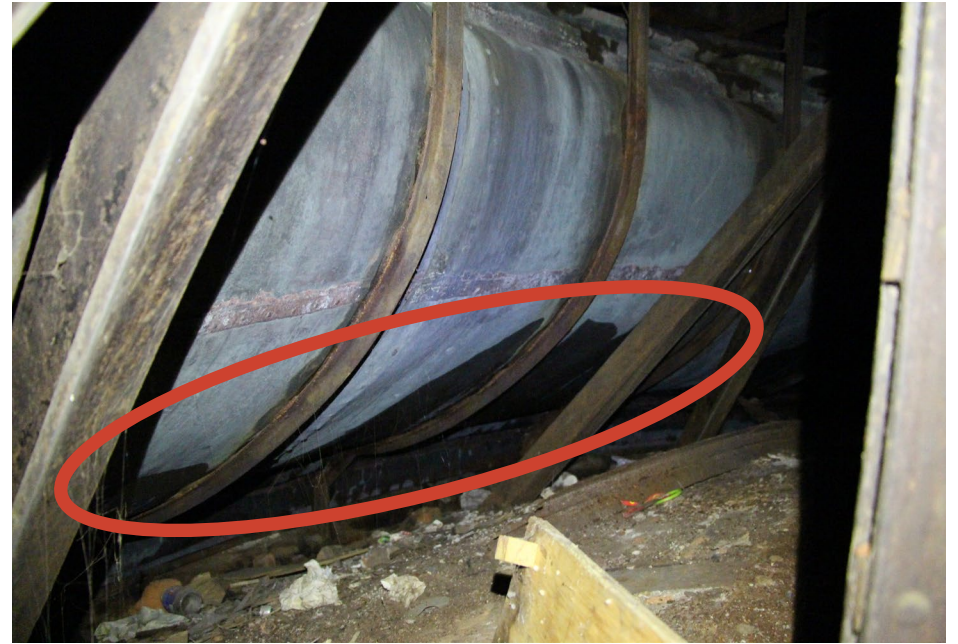
**Photo 15** Condensation observed on the underside of the lantern sheet metal cladding.

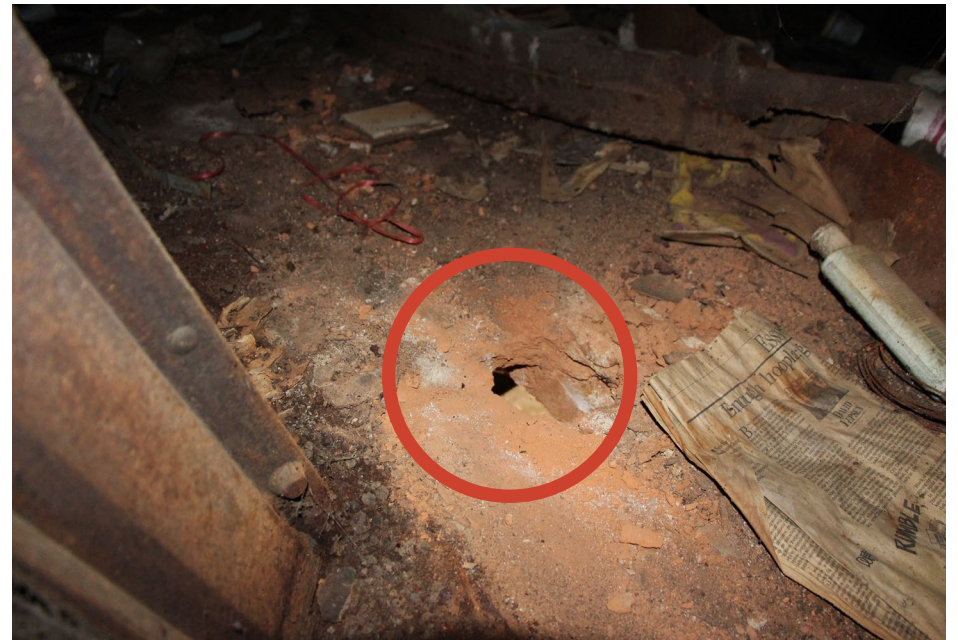
- The top surface of the main dome's brick vault is visible from the attic space. Its brick surface is typically covered with debris, but we also observed crumbling and deteriorated brick surface. We also noted one location with an approximately 4-inch diameter hole through the brick (Photos 17 and 18). We did not determine if this hole was man-made (e.g., for a conduit or similar that has since been removed) or the result of brick deterioration or damage. At this hole, we measured and confirmed that the brick vault is only one wythe (approximately 4 inches) thick.

**Photo 17** Top side of the dome's brick shell visible within the lantern attic; note hole in masonry.

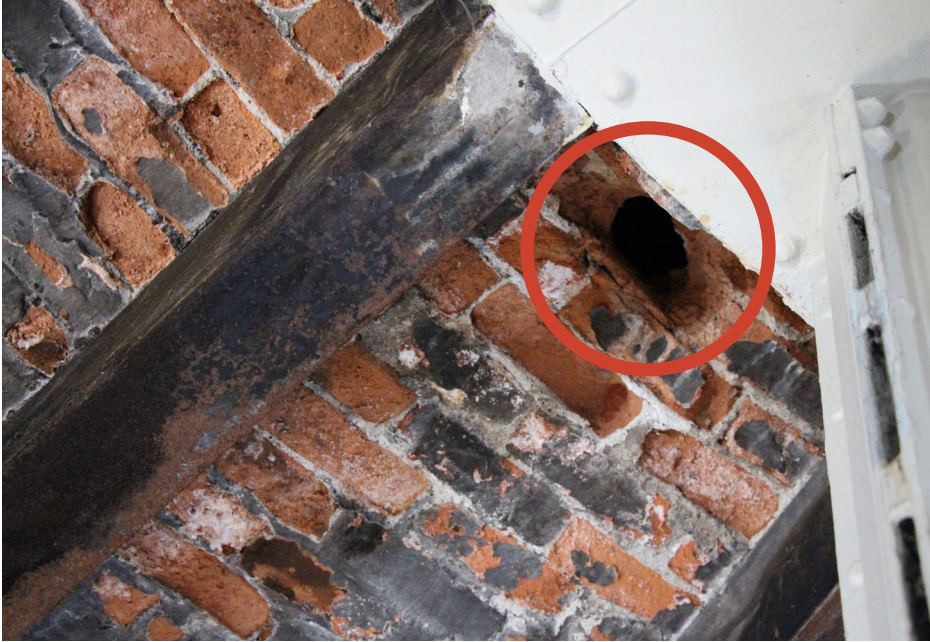
**Photo 18** Spalling brick at top of dome and underside of hole noted in previous photo.

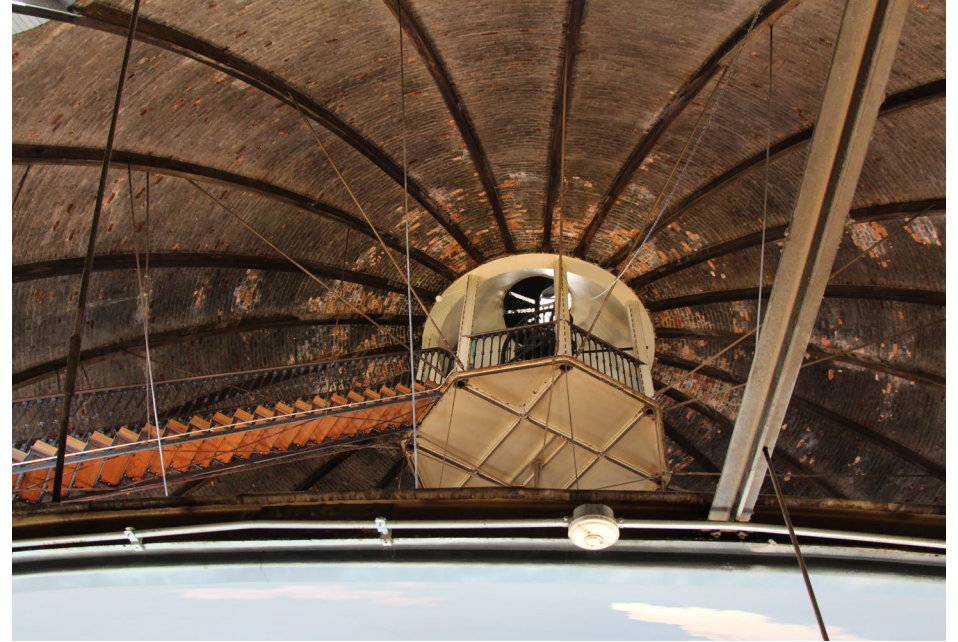
- The interior brick surface is deteriorated and crumbling at isolated locations (Photos 19 through 27). This deterioration typically consists of spalled brick shells that have exposed the red brick body below and has caused brick debris to fall to the top of the suspended sky dome and walkways below (Photo 28). Deteriorated areas with exposed red brick body are easily identifiable when compared to the dome’s typical dark brick surface that is due to an early nineteenth century fire (January 4, 1904) in the building. Deterioration is most prevalent in the uppermost 6 to 8 feet brick below the lantern attic (Photos 19, 24 and 25) and adjacent to isolated circular windows (Photos 26 and 27).

**Photo 19** Stair, platform, and lantern access. Note extent of brick deterioration (red brick areas) is concentrated at top of dome.

- Solution: Install working platform inside the main dome to allow access for repair and replacement of brick masonry as needed as well as future monitoring of interior masonry dome.

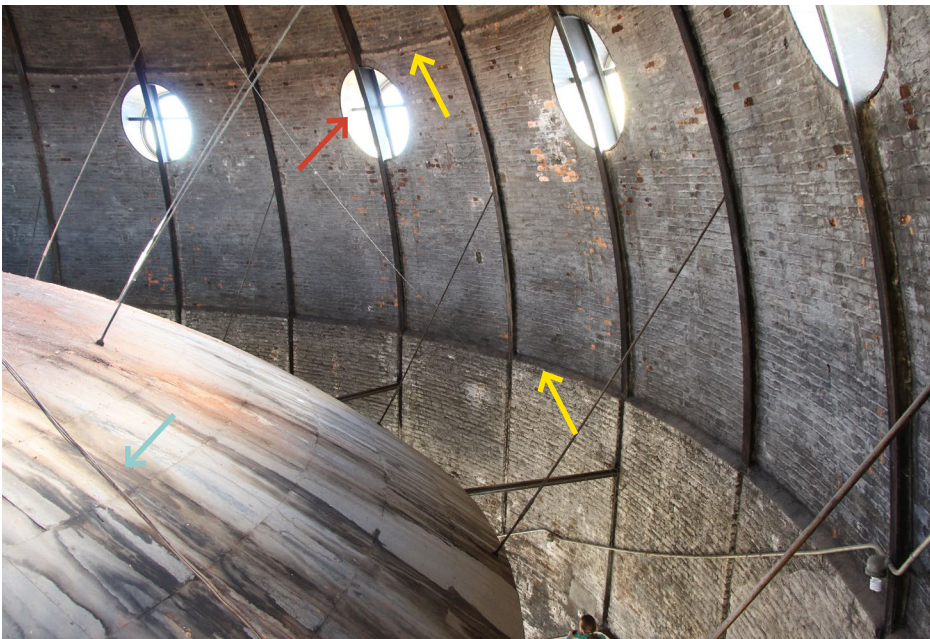
**Photo 20** Typical brick shell and ribs; note steps in brick thickness (yellow), horizontal bracing visible at windows (red), and suspended sky dome with water stains and brick debris (blue).

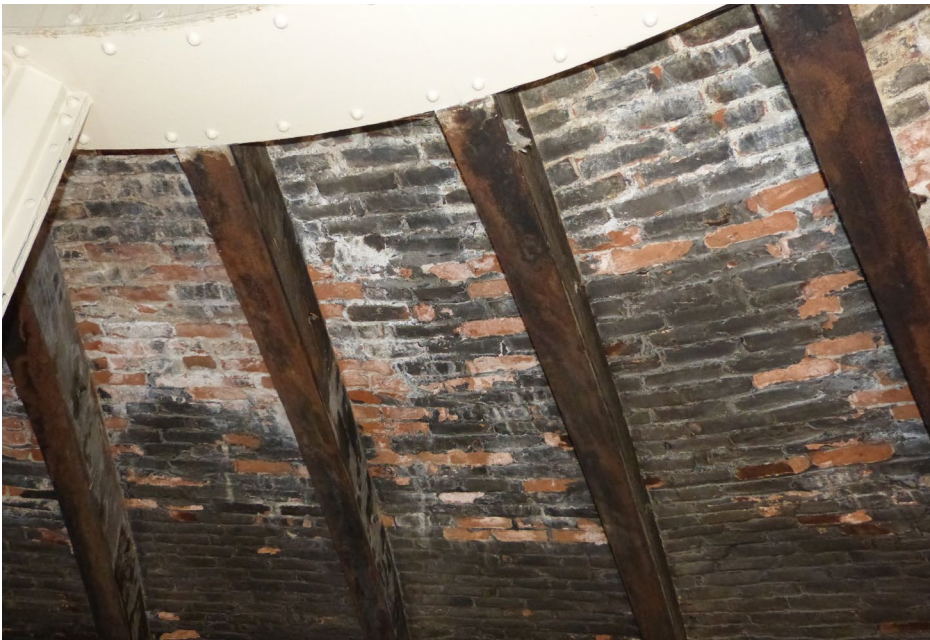
**Photo 24** Typical brick deterioration at top of dome.

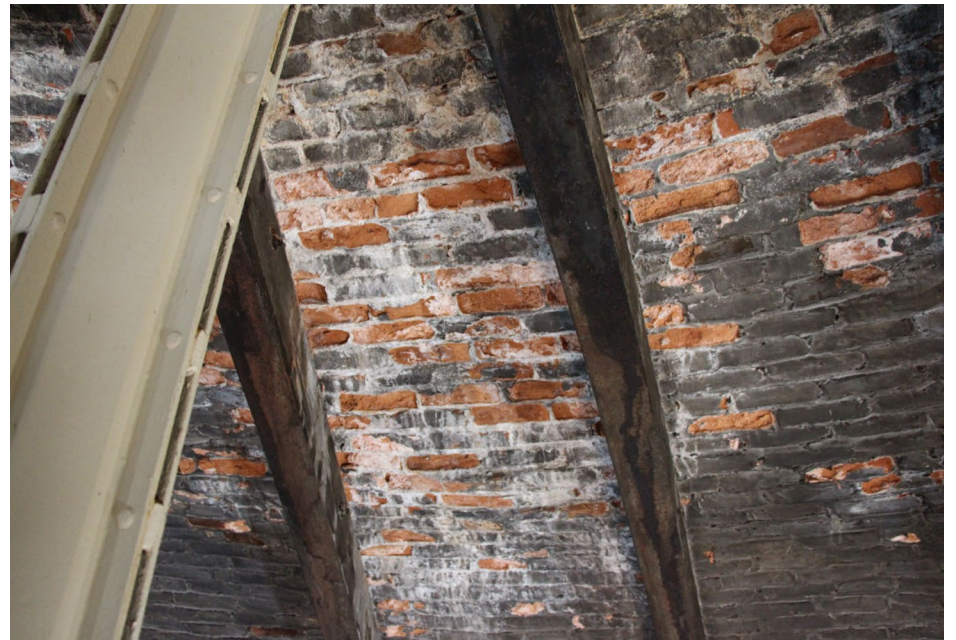
**Photo 25** Brick deterioration and efflorescence at top of dome, southeast quadrant.

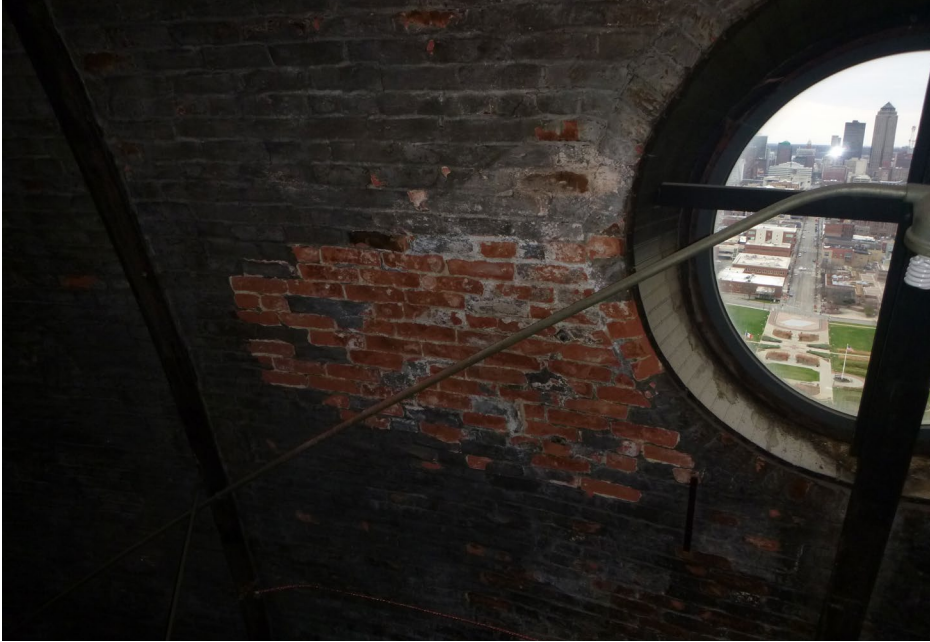
**Photo 26** Brick deterioration adjacent to west window.

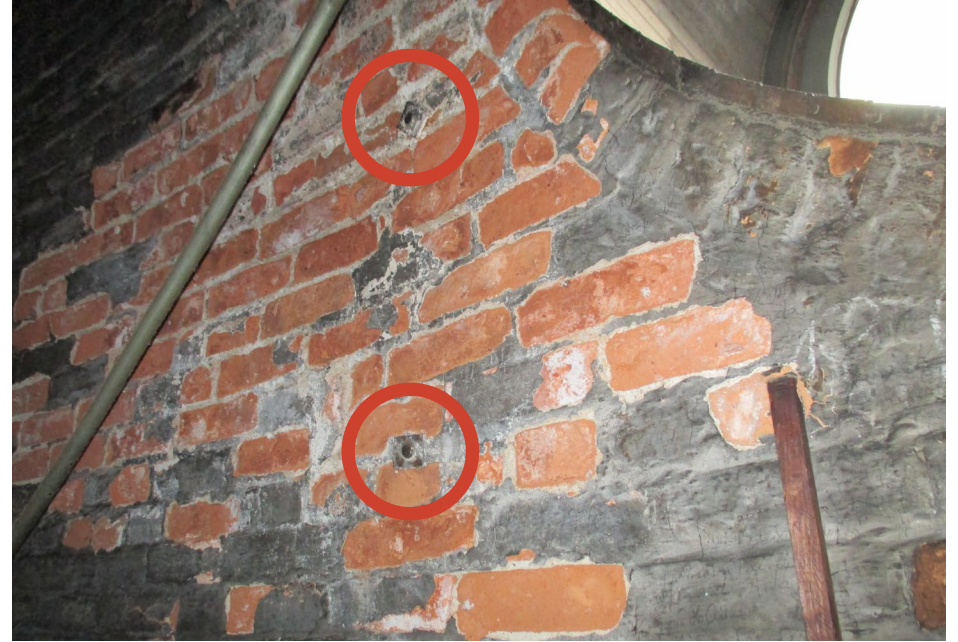
**Photo 27** Closer view of brick deterioration shown in previous photo; note anchor heads from original construction.

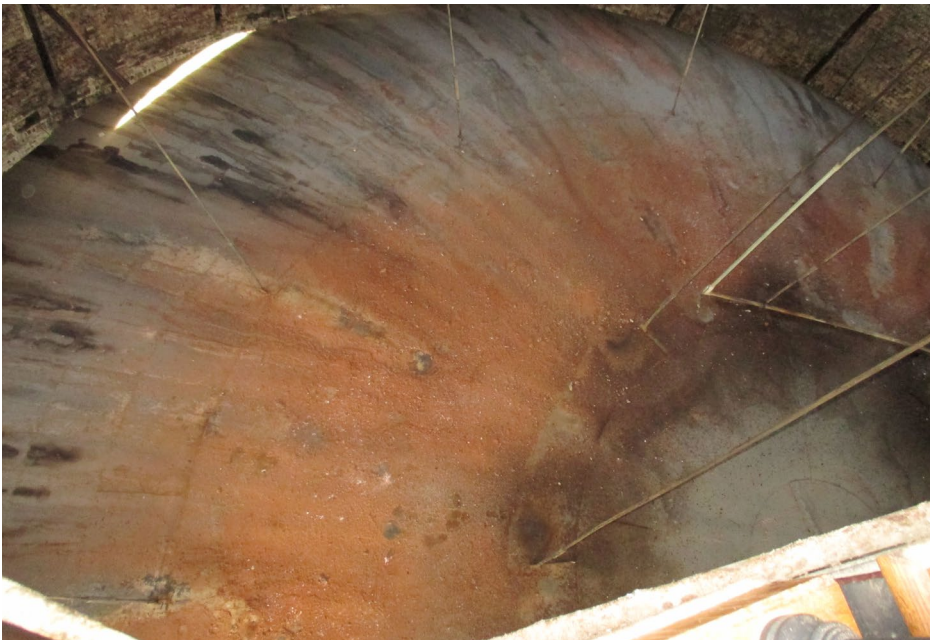
**Photo 28** Brick debris on top of sky dome.

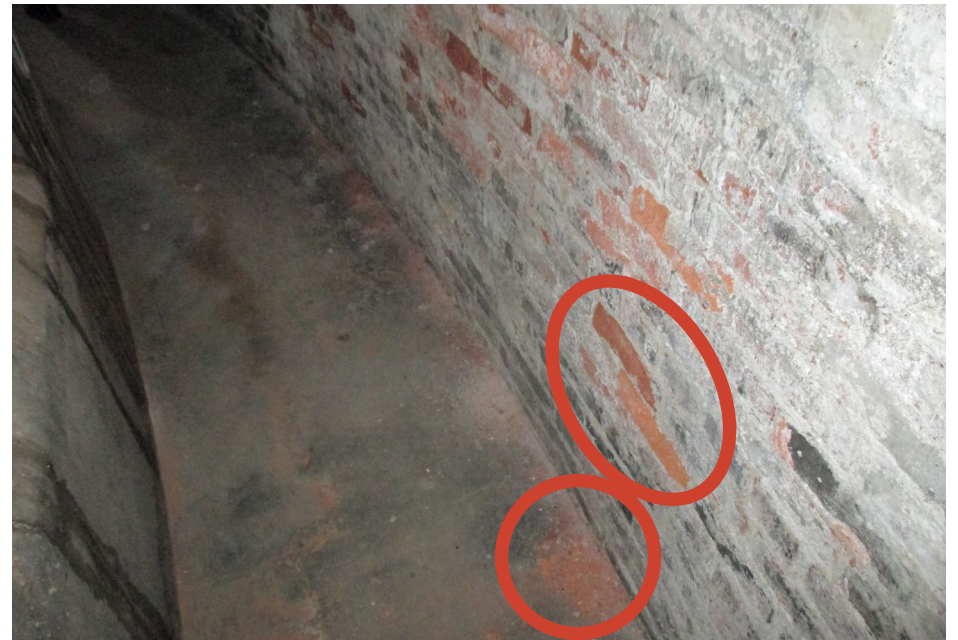
- We also observed isolated brick deterioration on the brick walls below the dome (Photo 29), though only within the northwest quadrant.
- We observed water staining on the wood sill at all accessible circular windows on Level K (Photos 30 and 31).

**Photo 29** Isolated brick deterioration and debris at base of dome.

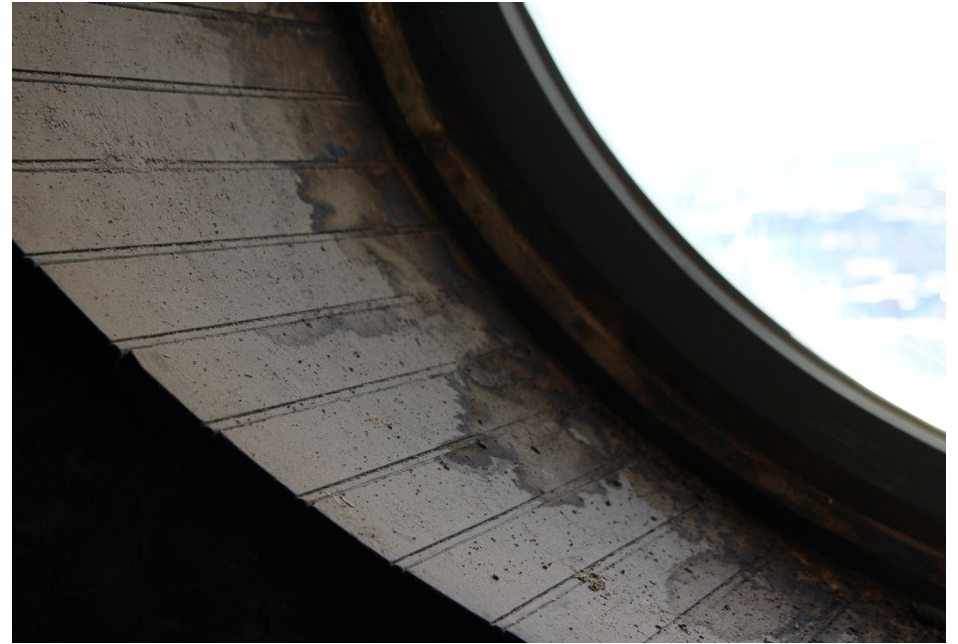
**Photo 31** Water staining on wood finishes at interior of window.

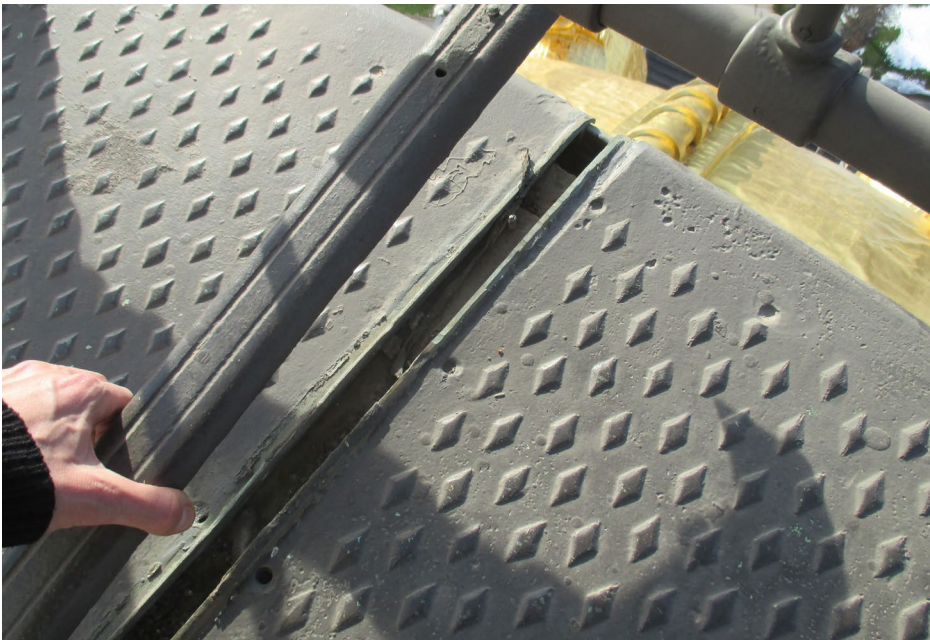
- Multiple covers are loose, and two could be lifted off the deck. At these locations, we noted that the underlying framing is severely corroded and anchors are no longer engaged (Photo 36). At these joints, we observed the top of the metal framing in the attic below. We saw no roof deck or waterproofing membrane below the planks.

**Photo 36** Unsecured cover; corroded framing is visible below.

- Solution: Provide plywood or heavy gauge sheet metal deck covered with continuous roof membrane under the observation metal deck planks. Repair the damaged masonry at the top of the dome with a new working platform.

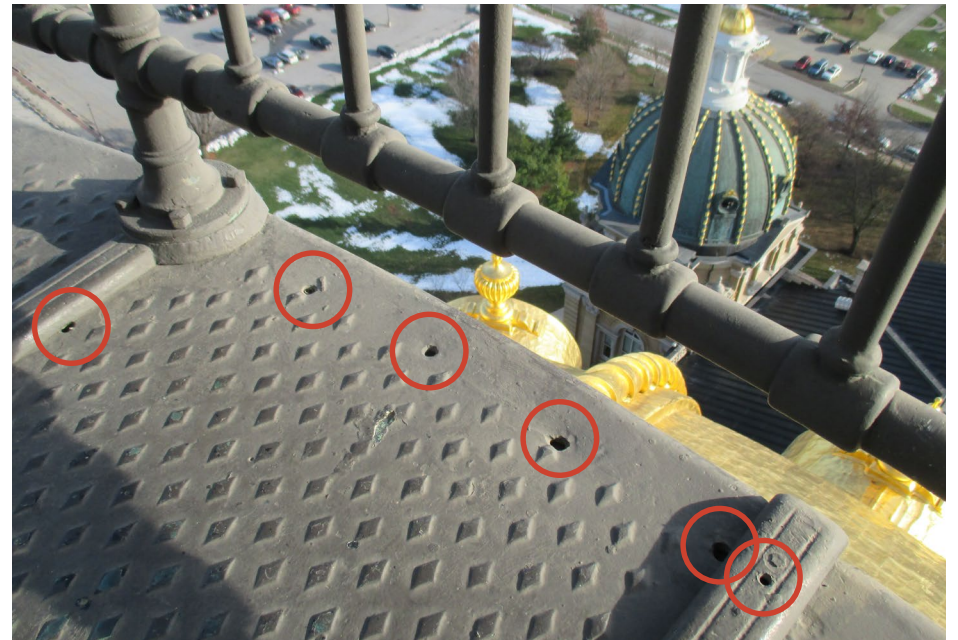
- In addition to the loose covers and open panel joints, we observed holes in several of the observation deck planks (Photo 37).
- At the lantern, the planks and covers have a slight upturn and are covered by the lantern cladding. At the observation deck edge, the planks and covers lap over the metal cladding below. This overlap is very small (visual estimate 1/4 inch), and we saw gaps at plank joint locations (Photo 38).

**Photo 37** Holes in observation deck plank.

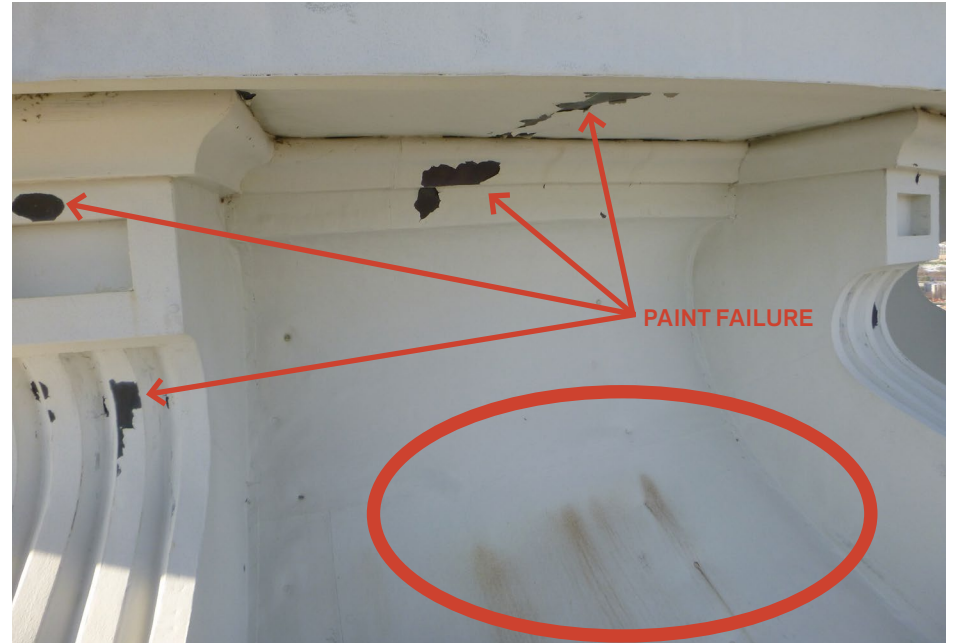
- We observed rust stains at multiple locations on the exterior of the lantern skirt (Photo 39 and 40) directly below the seams in the cladding soffit (horizontal interior shelf that collects water and debris shown in Photo 16).

- The paint on the metal cladding is peeling at some locations, including at panel seams (Photo 39). In addition to stains on the white painted skirt, rust-colored runoff appears to have stained the gilding below (Photo 41).

**Photo 39** Failing paint at soffit seam and rust stains on lantern skirt cladding below.

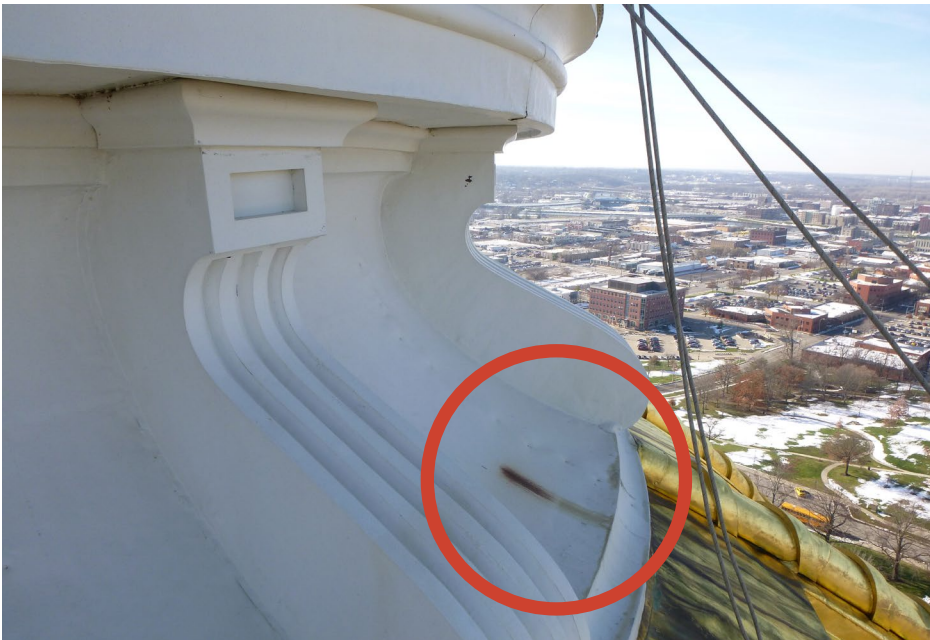
**Photo 40** Rust stain on skirt cladding below a seam in soffit.

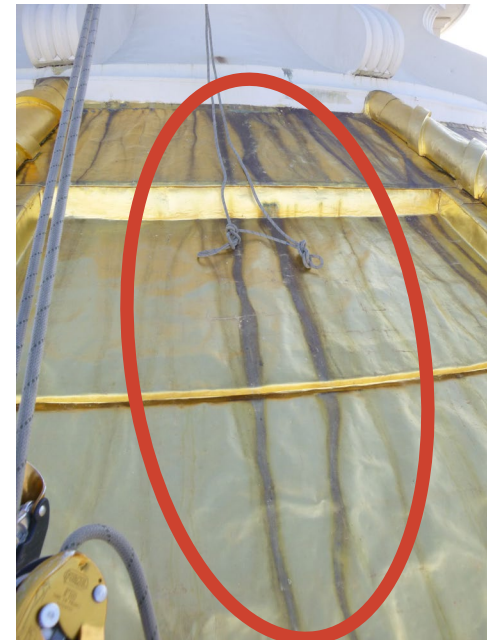
**Photo 41** Stains on gilding below rust stain noted in previous photo.

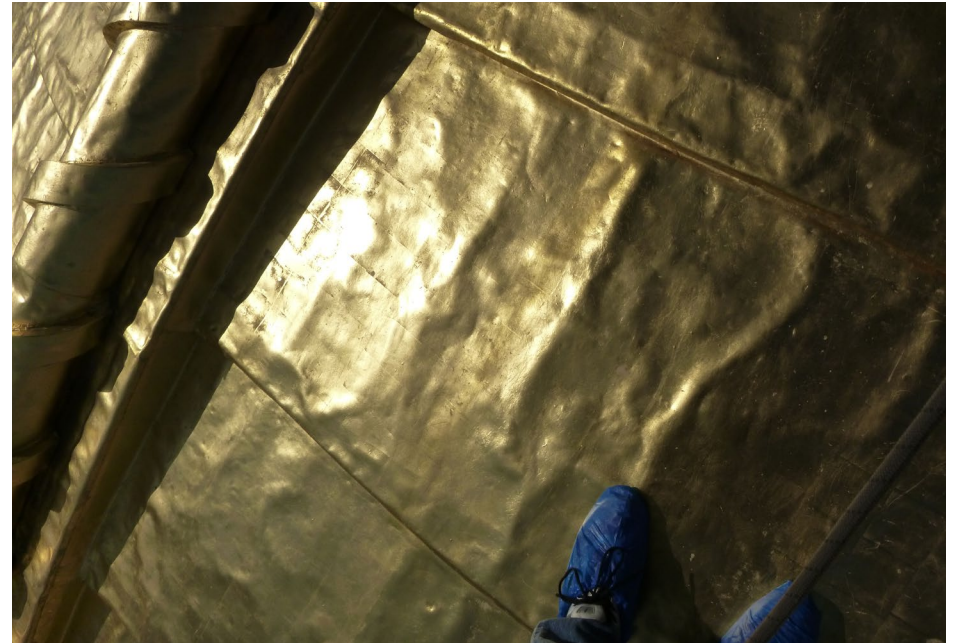
**Photo 51** Buckling and waviness typically observed in dome roofing sheets.

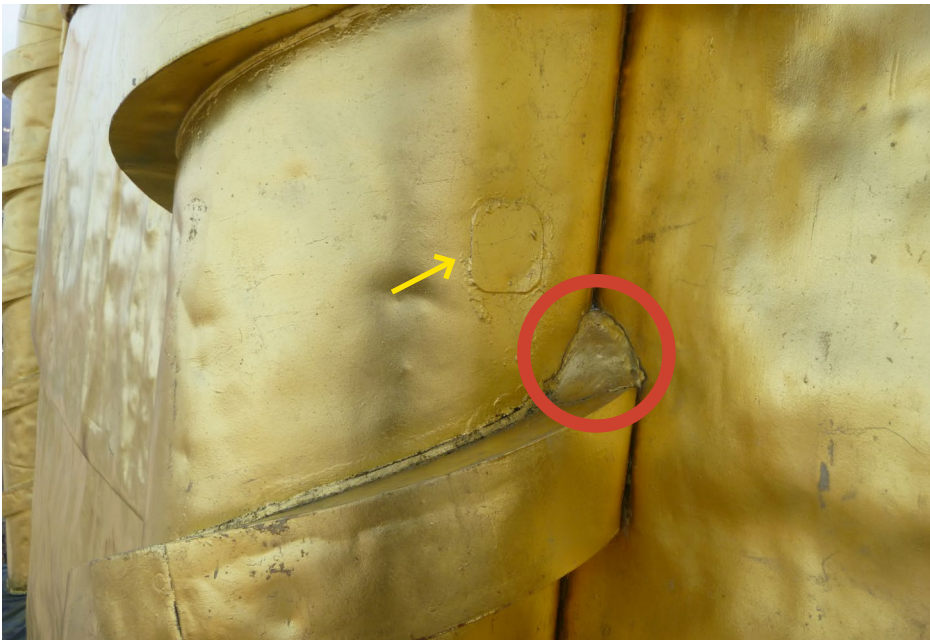
**Photo 52** Repair patch (yellow) and lead cant (red).

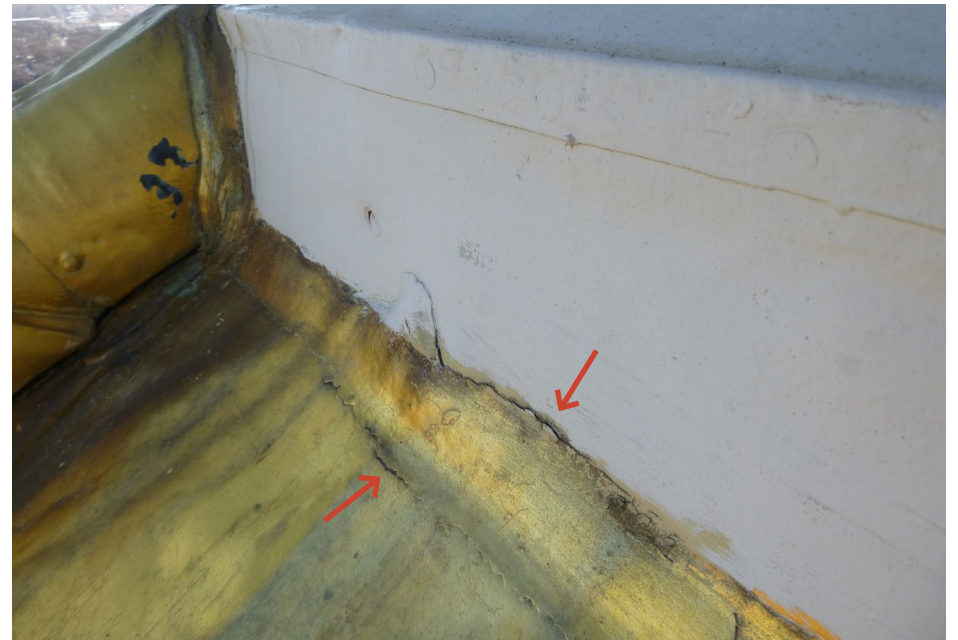
**Photo 53** Lead fillet at transition between dome roofing and lantern skirt cladding; note separation between fillet and roofing/cladding.

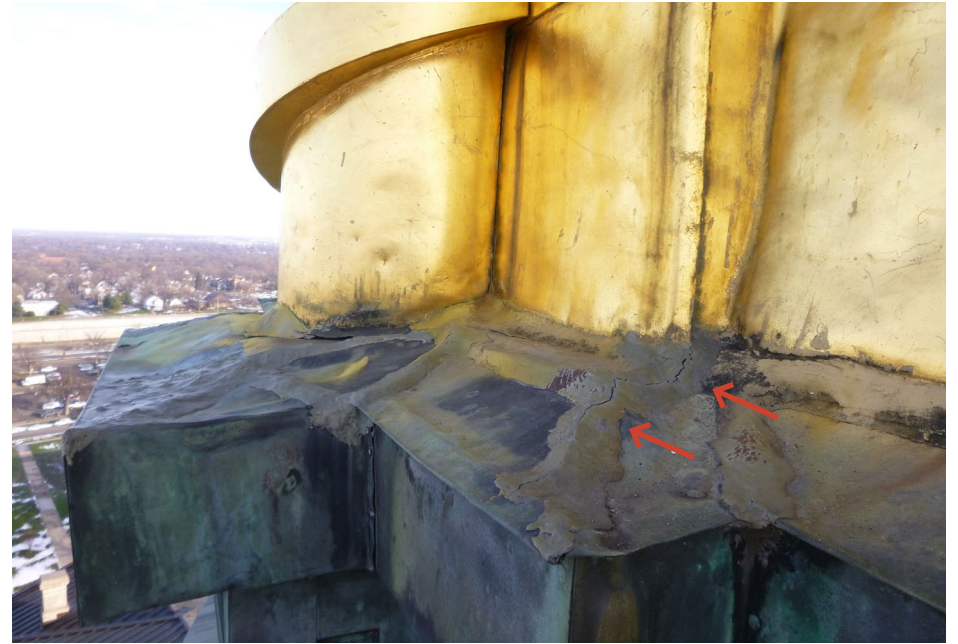
**Photo 55** Small cornice at top of copper entablature at base of dome; note cracked solder joints.

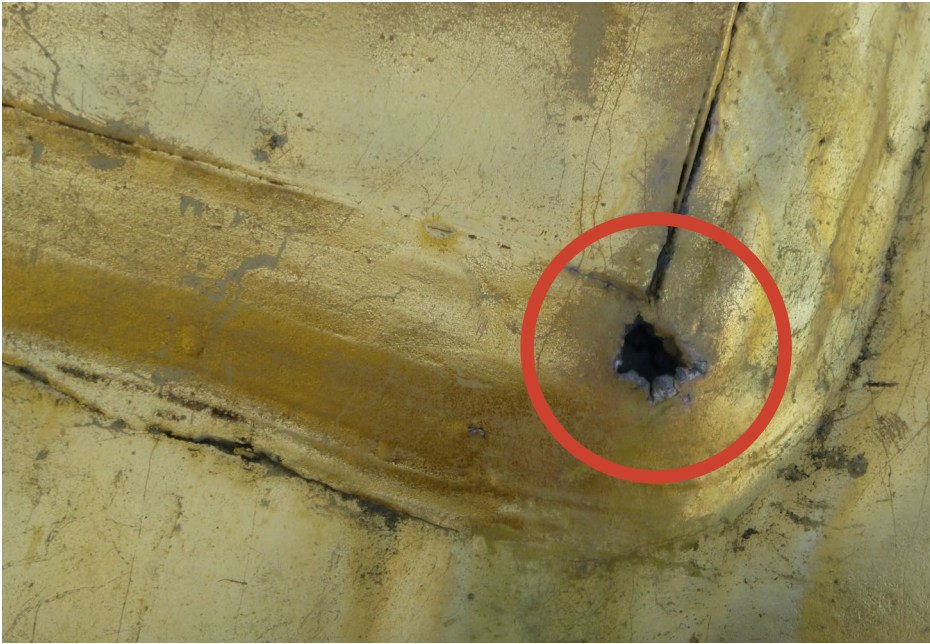
**Photo 59** Closer view of hole shown in previous photo.

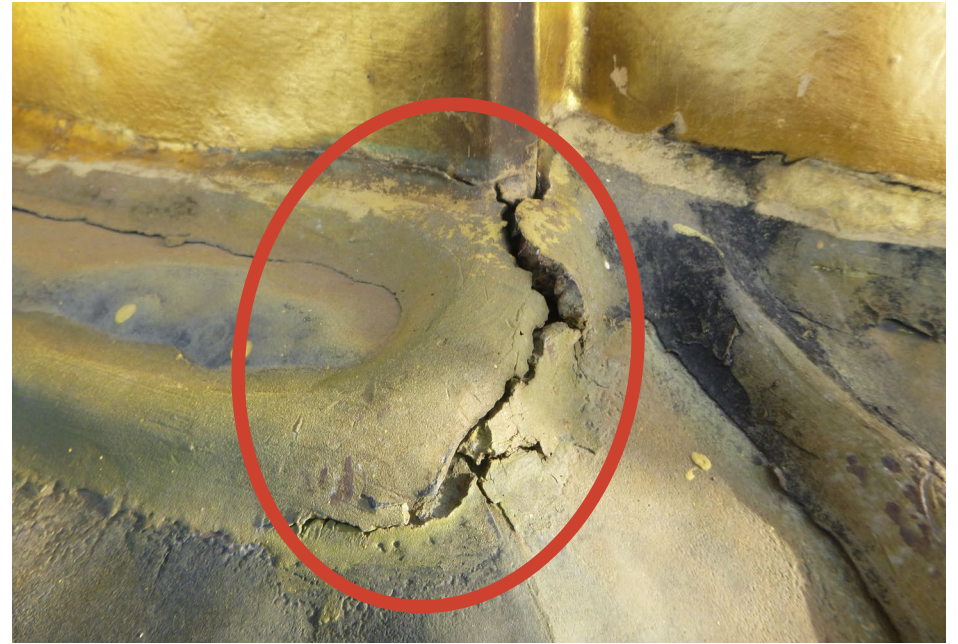
**Photo 60** Cracked solder joint (or lead) at small cornice at base of dome.

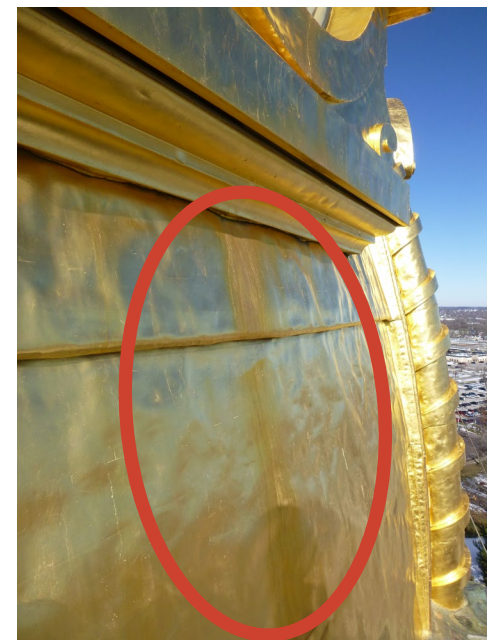
**Photo 62** Water stains originating from base of eyebrow dormer.

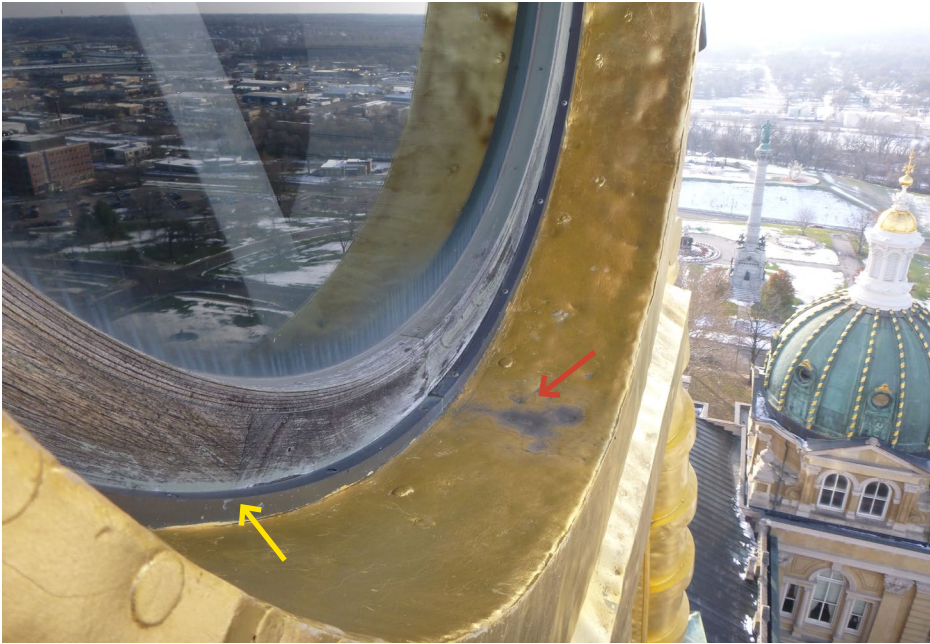
- Dormer circular windows consist of a painted wood frame and single-pane glass secured with a mechanically fastened wood stop (Photo 63). We saw no sealant or putty glazing perimeter seal between the glass and the stop. The window frame is secured into the dormer opening by a mechanically fastened metal stop; there is no visible seal between the window and stop, or between the stop and gilded dormer cladding. We observed water stains on the horizontal portion of metal at the bottom of each window. We noted condensation on the inside of the window glazing during cold morning conditions (Photo 64).

**Photo 63** Wood-framed circular window with unsealed metal stop (yellow); note water stain on metal cladding in front of window sill (red).

- Perform waterproofing repairs to address leakage through circle wood windows on the dome level.
  - Solution: Remove, salvage, reinstall and repaint window as needed to extend the life of the building.

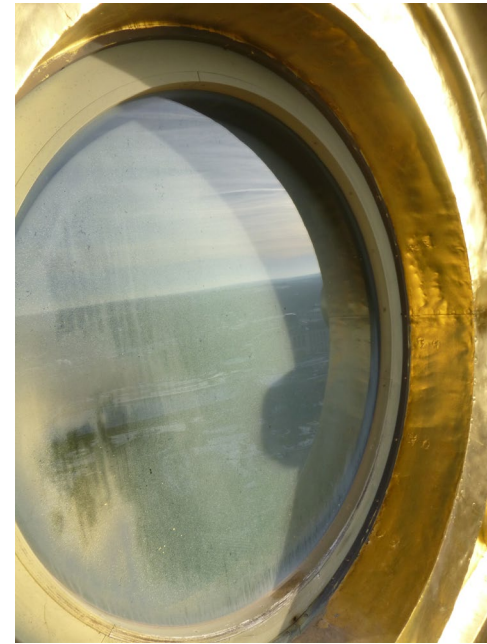
**Photo 64** Condensation on circular window interior.

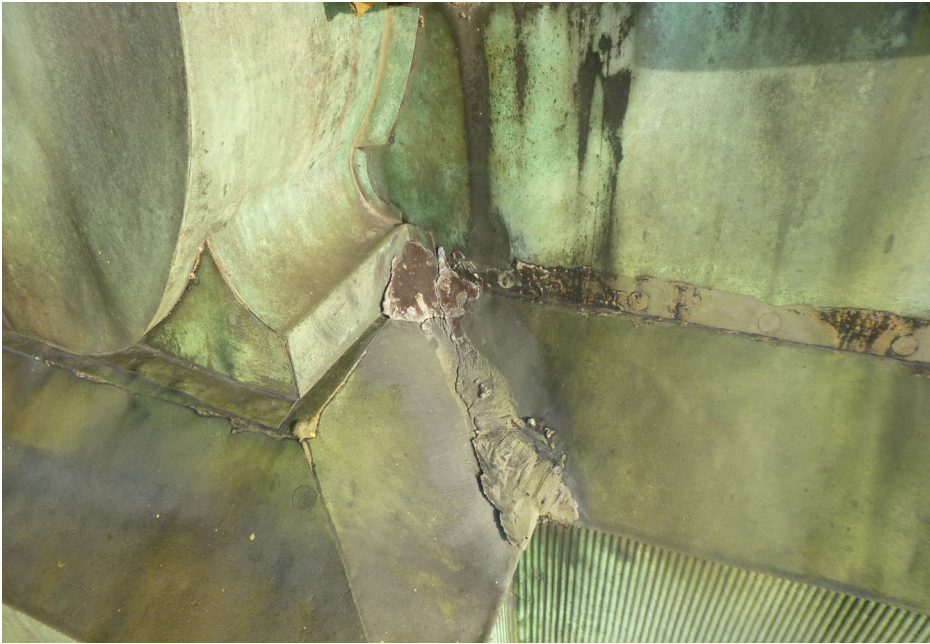
**Photo 67** Typical failed solder in skyward-facing joints of copper entablature at base of dome.

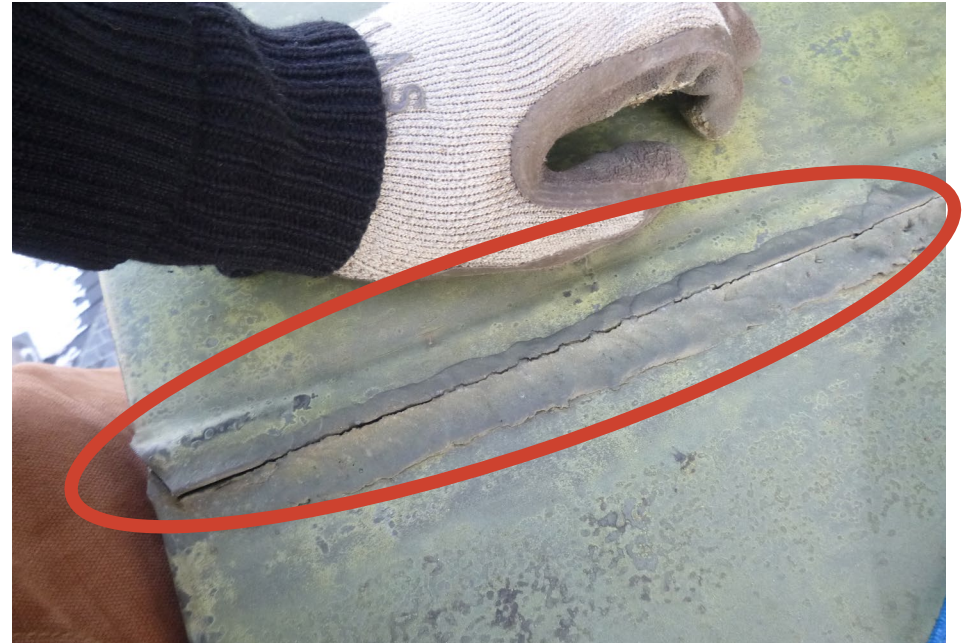
**Photo 68** Cracked solder joint in upper cornice flashing.
