## CAPITOL DOME STUDY FOR THE STATE OF IOWA

OPN Architects, Inc. + Simpson Gumpertz & Heger Inc. + Vertical Access LLC + Shuck-Britson, Inc.

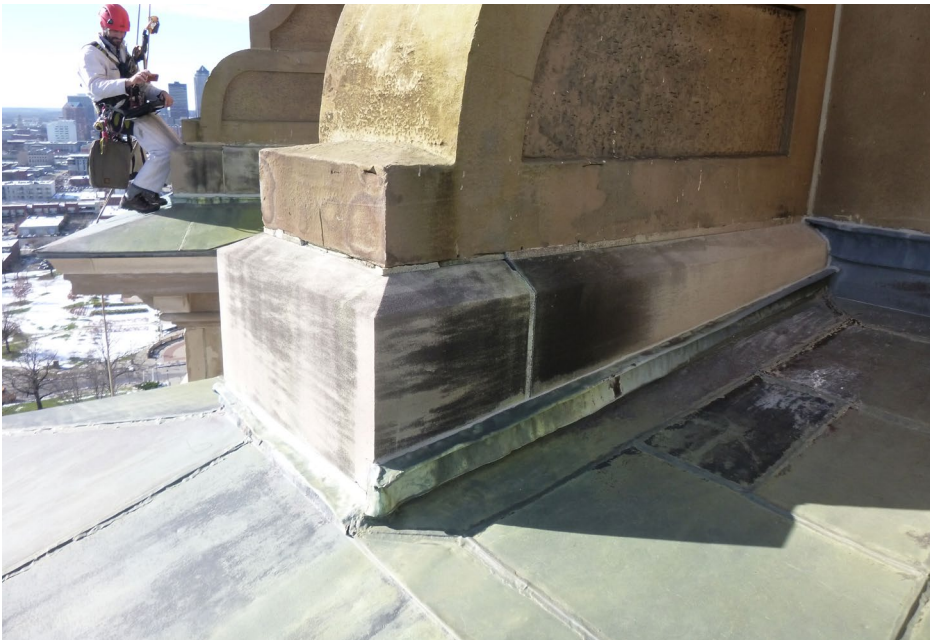
**Photo 69** Stone bracket at lower cornice; note failed mortar joints at base of bracket.

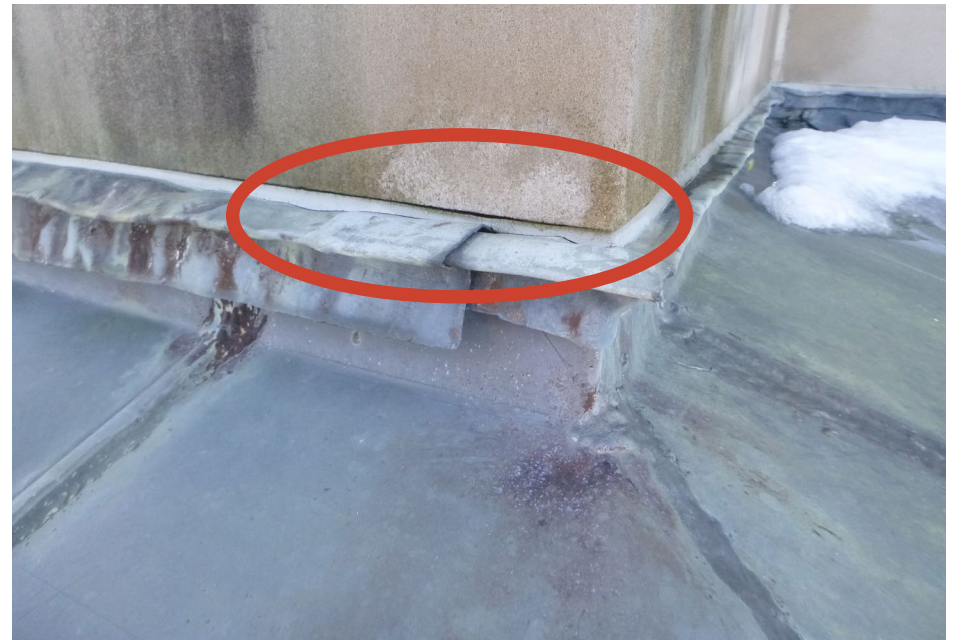
**Photo 70** Failed sealant and gaps in reglet-set counter flashing at lower cornice.

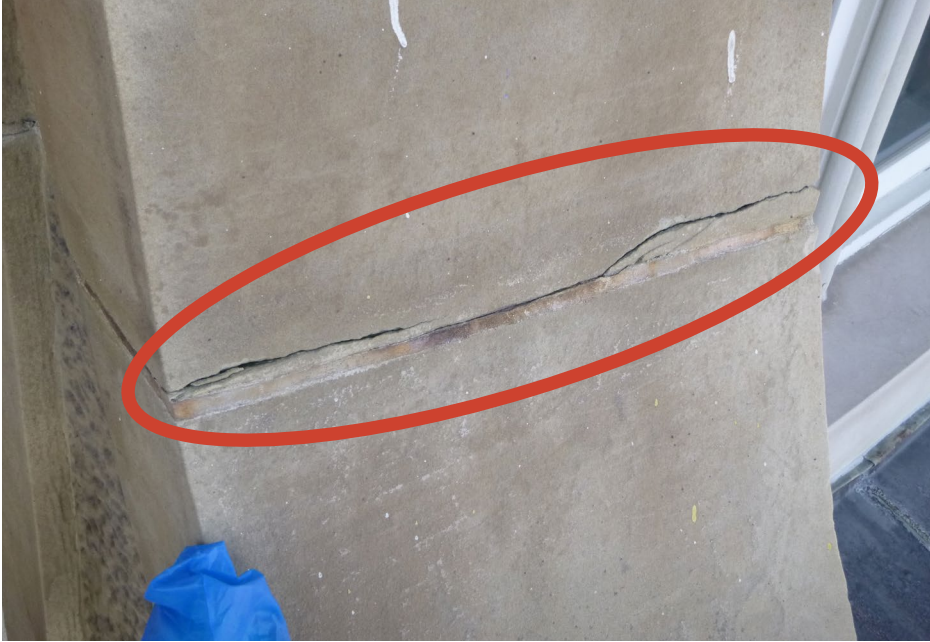
**Photo 71** Failed mortar joints in brackets above lower cornice.

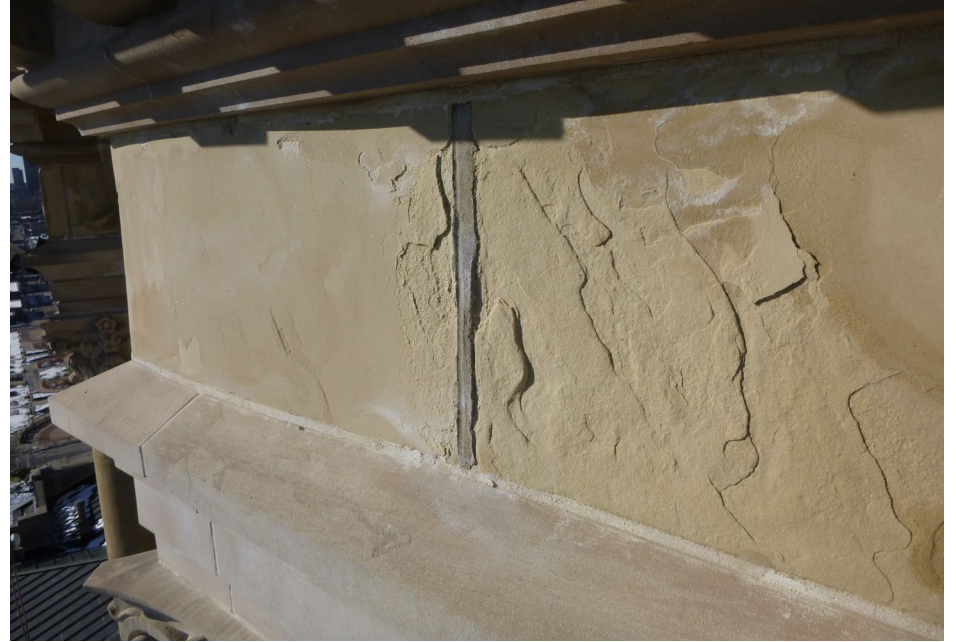
**Photo 72** Delamination at sandstone frieze within lower cornice entablature.

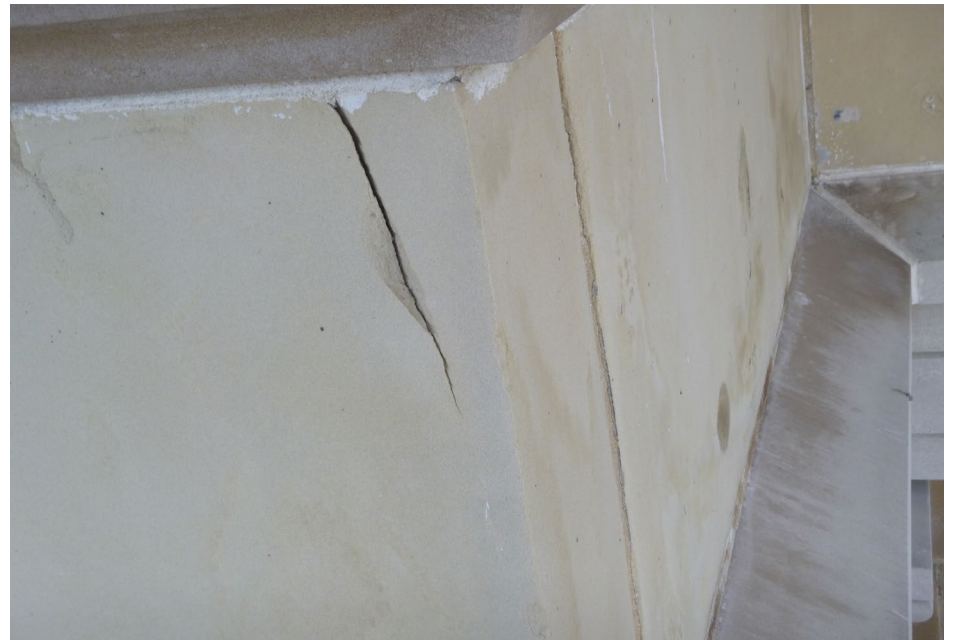
**Photo 74** Typical isolated masonry crack.

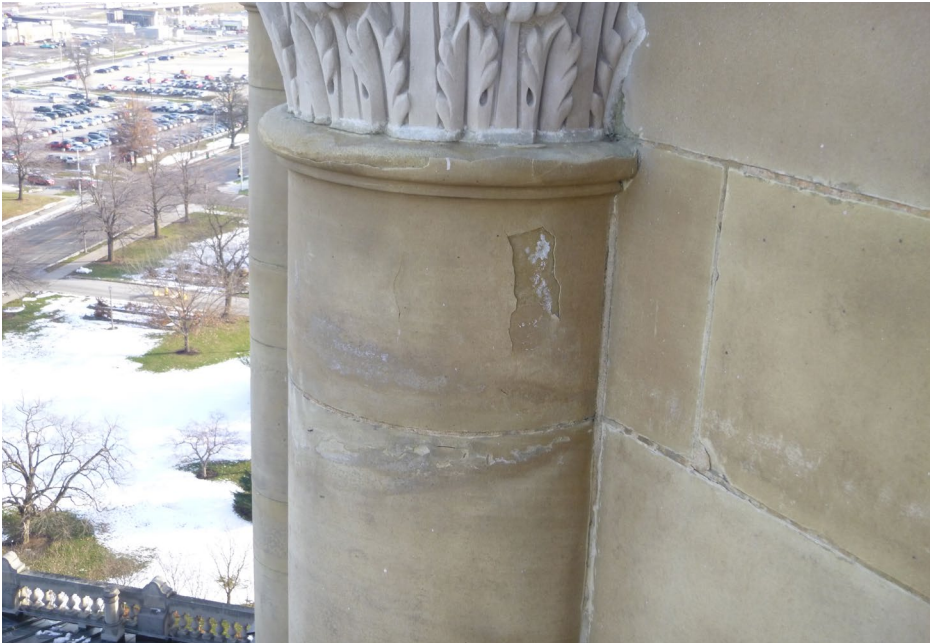
**Photo 75** Typical isolated delamination.

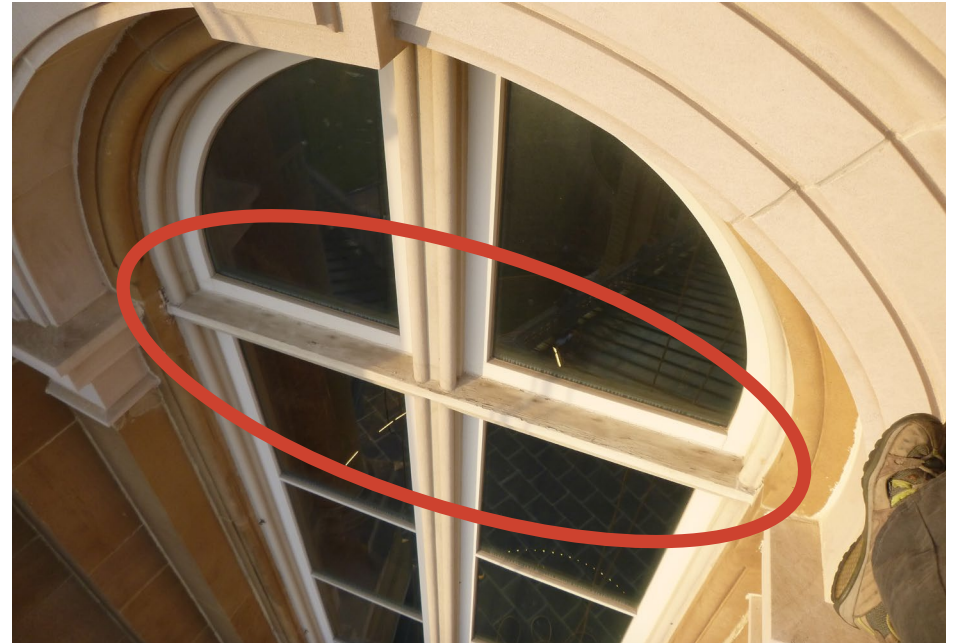
**Photo 76** Typical drum window; note failing paint on horizontal wood framing members.

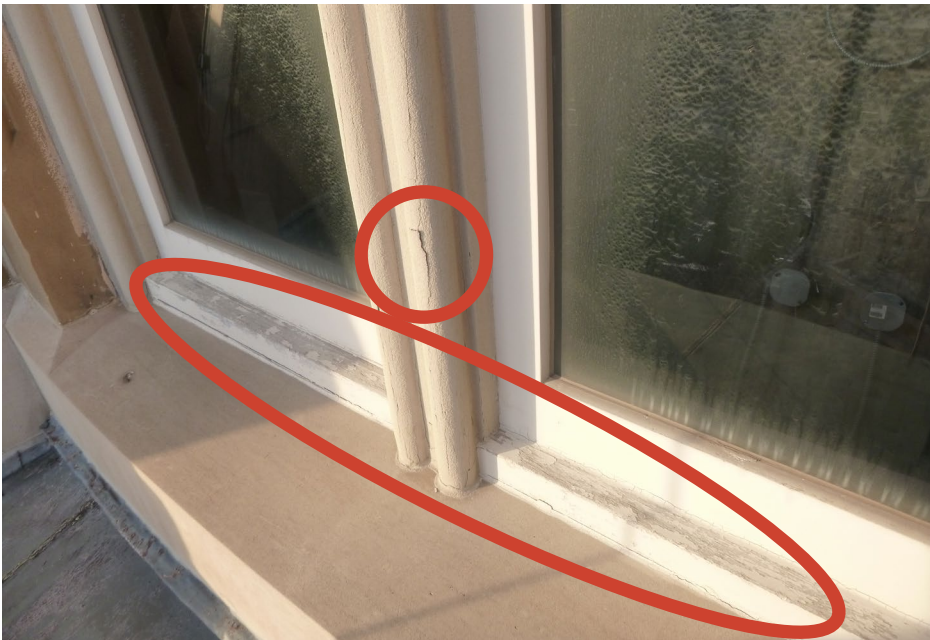
**Photo 77** Typical dome window; note failing textured coating on wood mullion and sill.

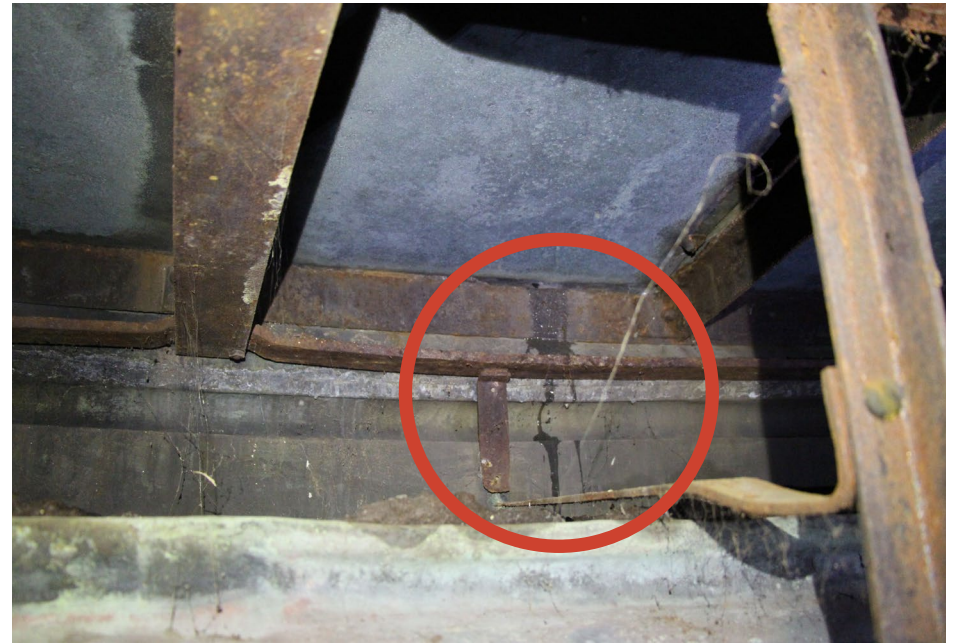
**Photo 80** Prompt leakage produced at observation deck water test.

- Solution: Provide plywood or heavy gauge sheet metal deck covered with continuous roof membrane under the observation metal deck planks. Repair the damaged masonry at the top of the dome with a new working platform.

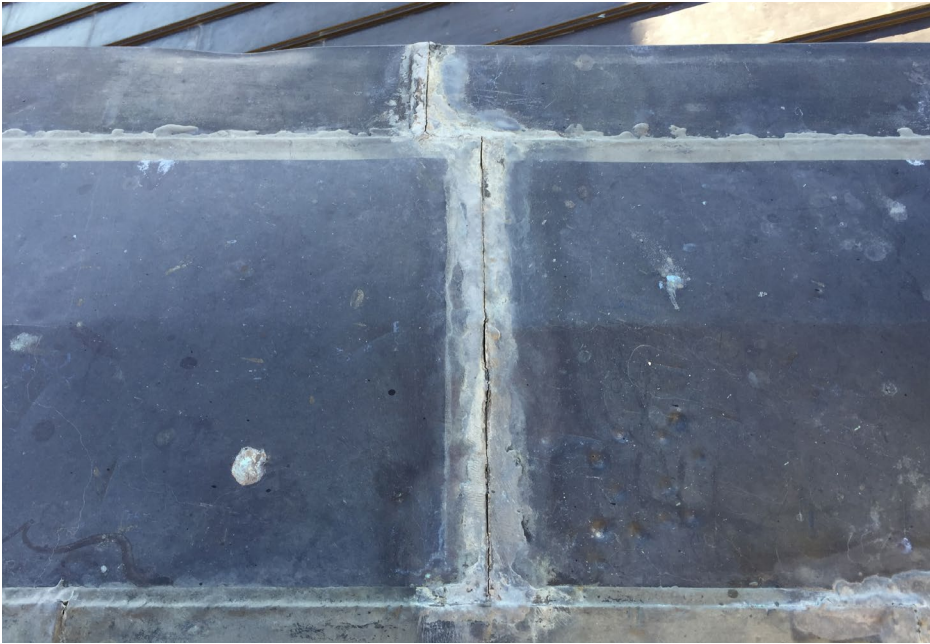
**Photo 83** Stylobate level - Solder joint failure.

- Solder water tight open seams and gaps in the copper flatlock at the stylobate level. During the restoration phases on the building similar items were reviewed in the spring and fall, as the falling of the snow and ice damage from the main dome extends on to the adjacent standing seam copper roofs.

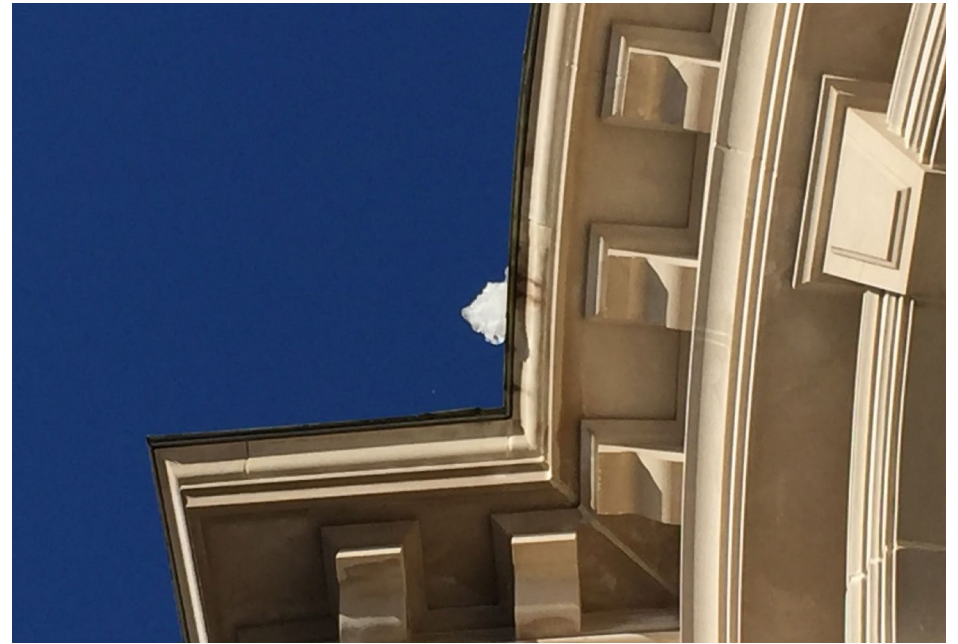
**Photo 84** Ice about to fall from the base of Level J intermediate cornice copper.

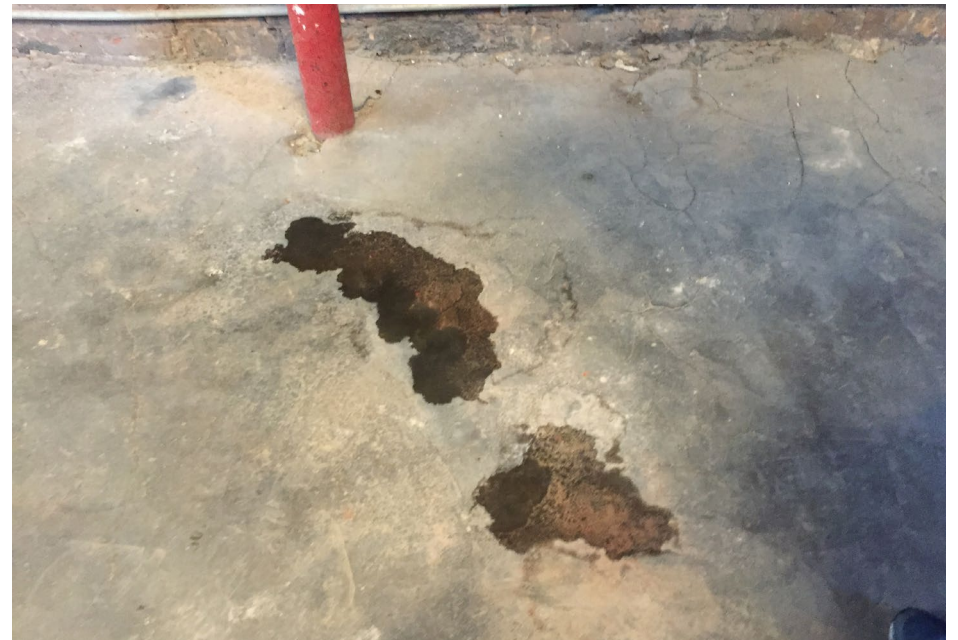
**Photo 86** Stylobate level - Active water leak to the attic floor.

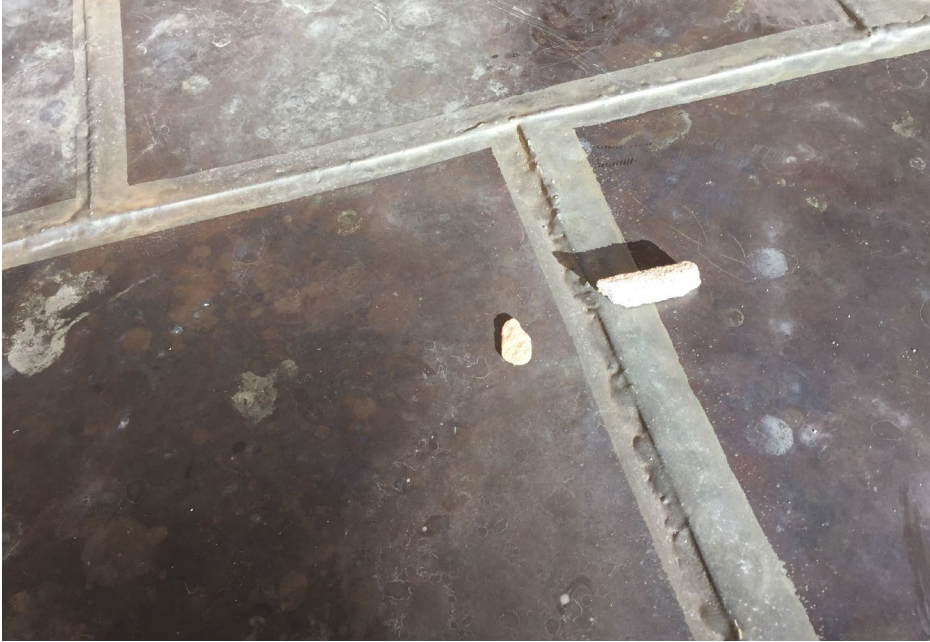
**Photo 87** Stylobate level - Masonry joint fallen from above on copper flatlock.
