FACT SHEET

Waterloo Maintenance Facility

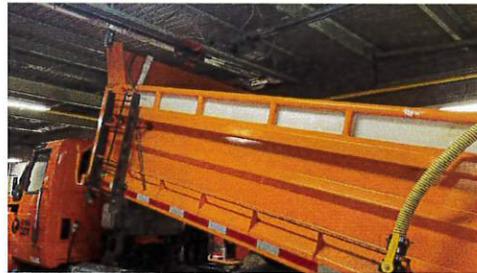
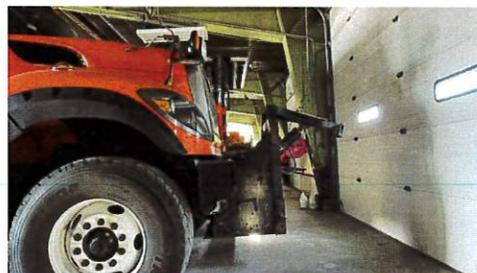
Not enough space of equipment; plow attachment is at centerline.

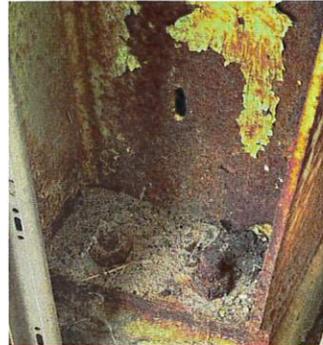
Structural steel beginning to corrode.

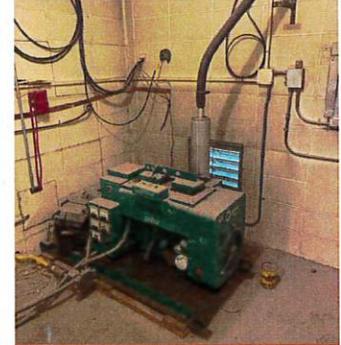
Electrical system and backup emergency power undersized.

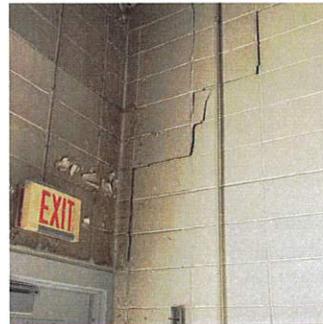
- Due to the original time of construction, the building does not have insulation, and components would have to be wholesale replaced.
- The exterior and interior masonry walls have sustained extensive cracking.
- The antiquated electrical systems and emergency support generators are insufficient to operate the facility.
- Many of the facility's drains and/or pipes are deteriorating and are a maintenance issue. A new facility would provide modern pit intake drains and newer synthetic pipe materials in place of the older trench drains and steel pipe.
- The entire modified bitumen and epdm roofing systems are over 25 years old and have surpassed their useful life.
- The existing steel columns, overhead doors, and passage doors all exhibit corrosion and deterioration.

Cracked and deteriorated interior masonry.

When a building has aged and weathered beyond repair like this one has, the most cost-effective route is to rebuild.

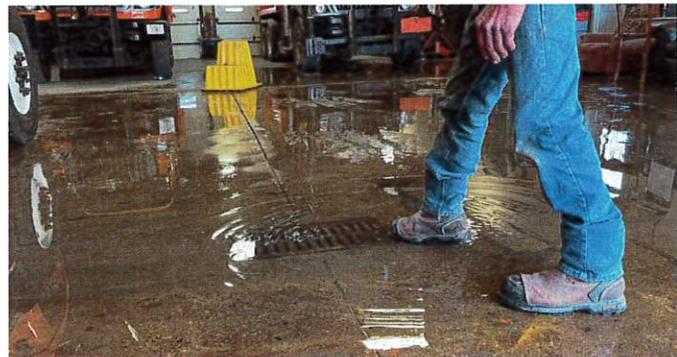
Deteriorating drains create a maintenance issue.
