HUNGRY CANYONS ALLIANCE

The Problem

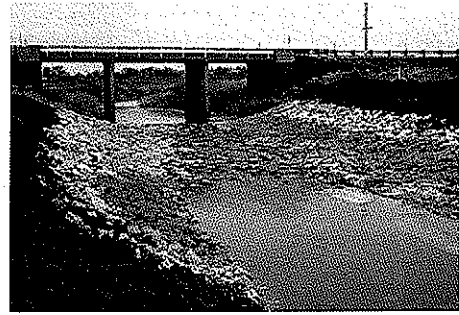
Crawford County sheet pile weir with a 20:1 grouted riprap slope

The HCA has been working with the Iowa Department of Natural Resources (DNR) to design and construct weirs that will allow fish to migrate upstream. First, the DNR and HCA had a series of meetings to determine which streams were priorities for fish, such as catfish, to be able to migrate up and down. Second, the DNR and HCA agreed on a design that will allow fish migration. The design, exemplified by this recently completed structure (shown at right), consists of a 20:1, horizontal-to-vertical, grouted rock slope downstream from a V-notch sheet pile weir.

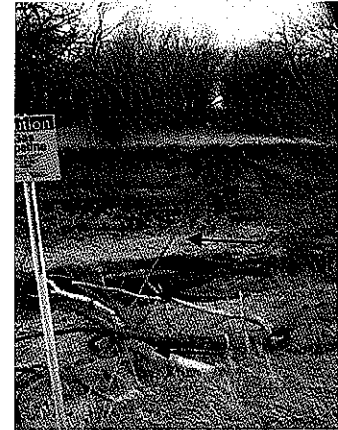
This stream has downcut enough that a once buried gas pipeline was exposed and then severed by a falling tree in Nebraska.

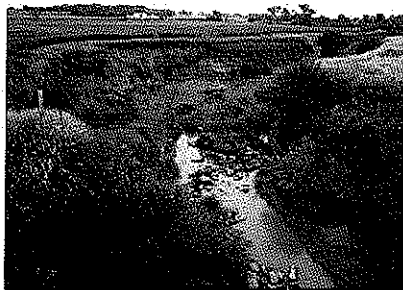
Degradation on this stream has caused the near-vertical actively-eroding streambanks in Nebraska.
