## CAPITOL DOME STUDY FOR THE STATE OF IOWA

OPN Architects, Inc. + Simpson Gumpertz & Heger Inc. + Vertical Access LLC + Shuck-Britson, Inc.

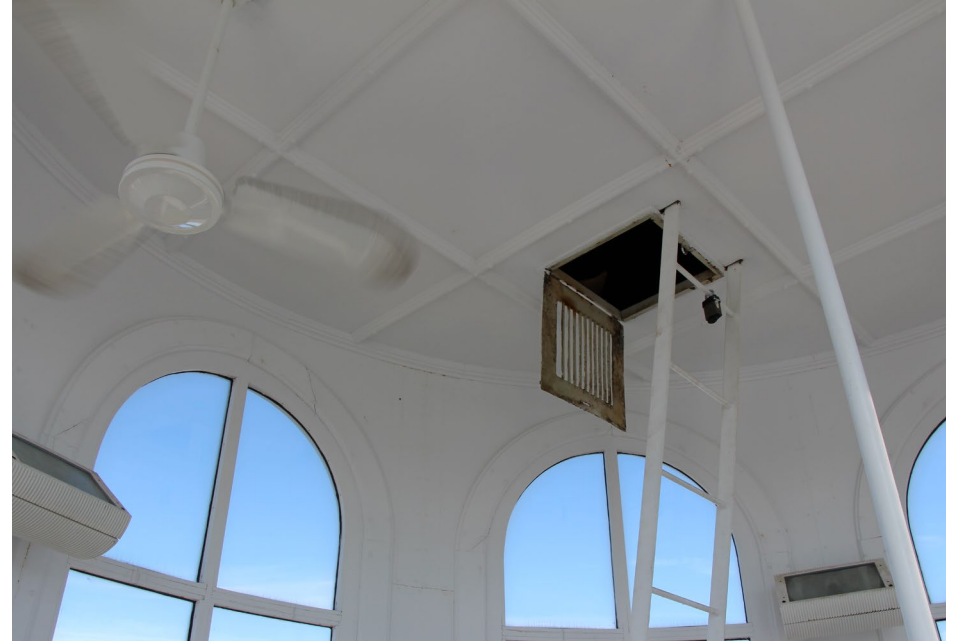
The lantern dome is accessible via a built-in ladder and a small hatch in the lantern ceiling (Photo 2). We note the following observations relevant to our work:

- The ceiling access hatch has a louvered trap door that allows airflow between the dome and lantern below (Photo 2). The dome roof has no louvers or other openings that allow ventilation to the exterior.

- The lantern has two ceiling fans, which ran continuously during our time onsite (Photo 2). The 1997 Phase 9 restoration drawings show adding these fans using the existing electrical within this space. We saw no louvers or other roof openings that would allow for venting this space to the exterior. We felt a strong and sustained airflow to the exterior when we opened the observation deck door to the exterior.

**Photo 2** Lantern ceiling. Note grated hatch into lantern dome attic and ceiling fan.

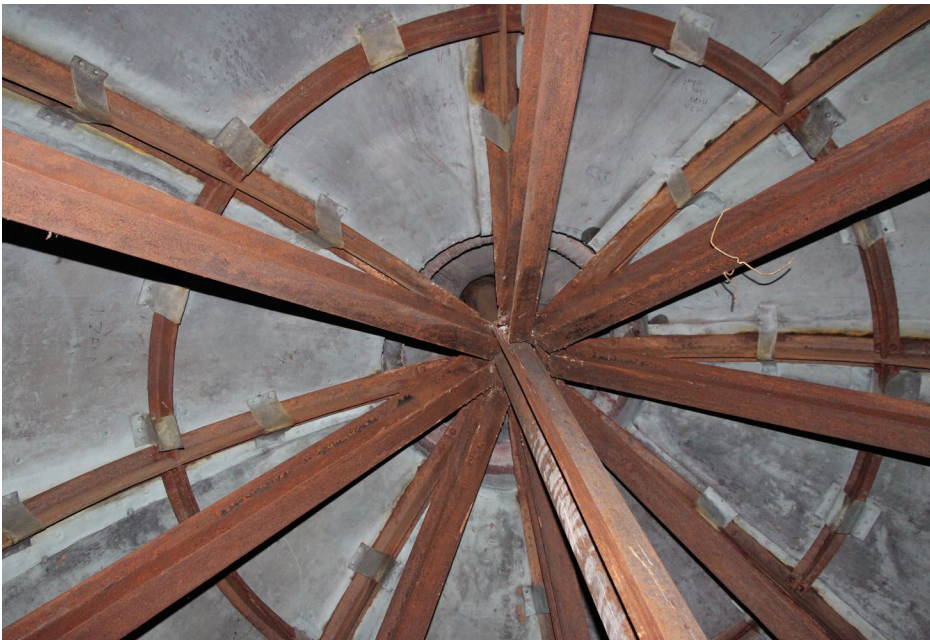
- The underside of the dome's sheet metal roof is visible (Photos 3 and 4); there is no deck (other than wood blocking to support a projecting cornice) or secondary waterproofing system behind/under the metal roofing. The sheet metal is secured to the metal structure with riveted sheet metal clips.

The lantern dome is supported by 8 cast-iron radial ribs (Photo 3). The radial ribs extend from the braced compression ring at the base of the dome to a cast-iron compression ring at the top. Purlins span between radial ribs which support the copper sheeting that forms the lantern dome.

**Photo 3** Metal framing and underside of lantern dome sheet metal cladding.

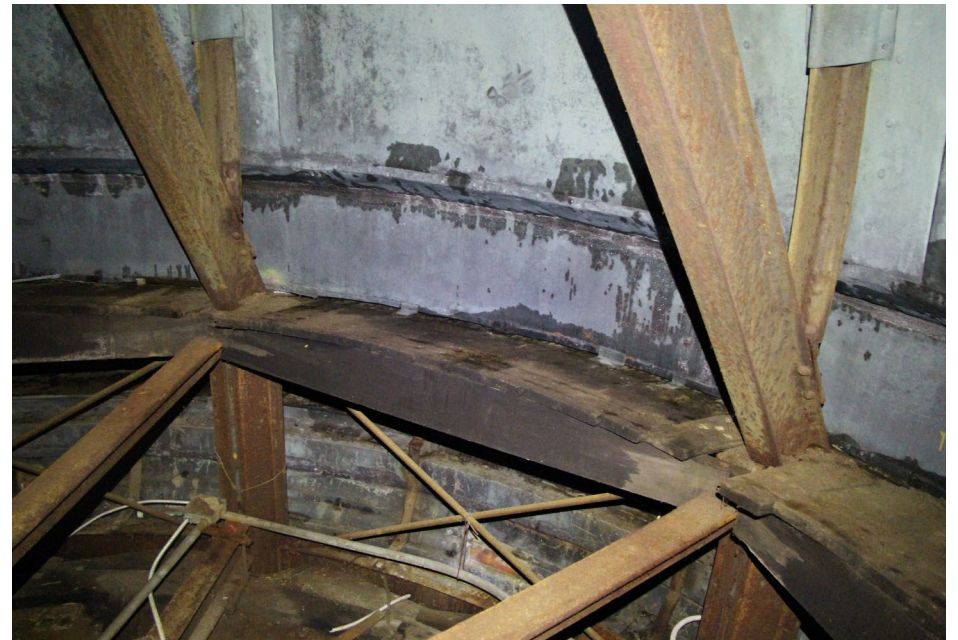
- We observed condensation on the back side of the dome's sheet metal roofing and cladding (Photo 4). We are certain this moisture in Photo 4 is due to condensation and not leakage as the moisture was observed on a cold morning, several days after the most recent snow/rain. The moisture was also more prevalent on the north and west elevations, which had not yet seen any direct sun at the time of our observations. During the November 23 through 25, 2015 site visit, the condensation was observed collecting on a horizontal soffit formed with sheet metal cladding and metal support framing near the roof eave (Photo 6). Wood blocking and metal framing components that abut the cladding are typically water stained.

**Photo 4** Condensation on backside of sheet metal cladding at the base of lantern dome.

- Address the condensation issues at lantern level and top of the dome.
  - Solution: Engage an MEP consultant to assess the current HVAC system and control systems. We understand that many of the existing HVAC systems are not currently in operation and should be placed back into operation to limit relative humidity within the building, particularly during cold winter months. Review with an MEP consultant the options to increase the ventilation of the lantern while limiting the amount of high humidity passing through the interior of the dome. Excess moisture in the air in contact with the uninsulated dome and sheet metal is an important issue to address for the life of the building.

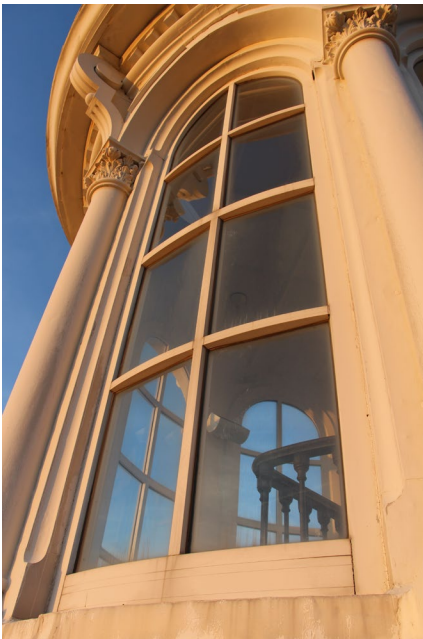
The lantern consists of two levels – a lower enclosed level with a door to the observation deck and an upper level with eight large arched divided-lite wood windows (Photos 7 and 8). The lantern interior is finished with painted wood cladding and window trim. We note the following observations relevant to our work:

**Photo 7** Typical lantern window.

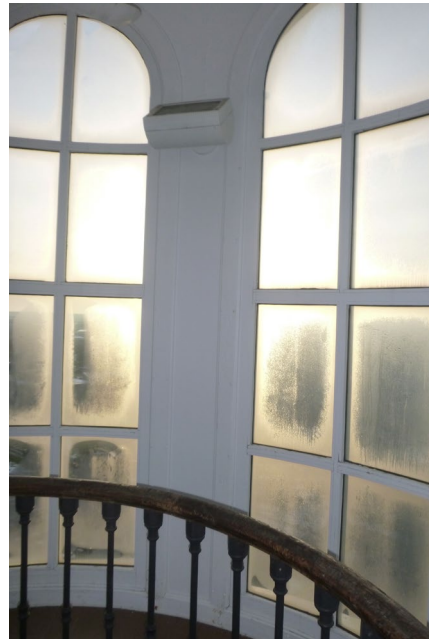
- We observed condensation on interior face of the lantern window glazing (Photos 8 and 9). Wood finishes around the windows are water stained, particularly at horizontal mid-rails (Photo 10) and the base of the windows (Photo 11).
- Lantern glazing is single pane glass. The 1997 Phase 9 restoration drawings provided for new windows. The use of

**Photo 8** Lantern interior with typical condensation observed on glazing in morning.

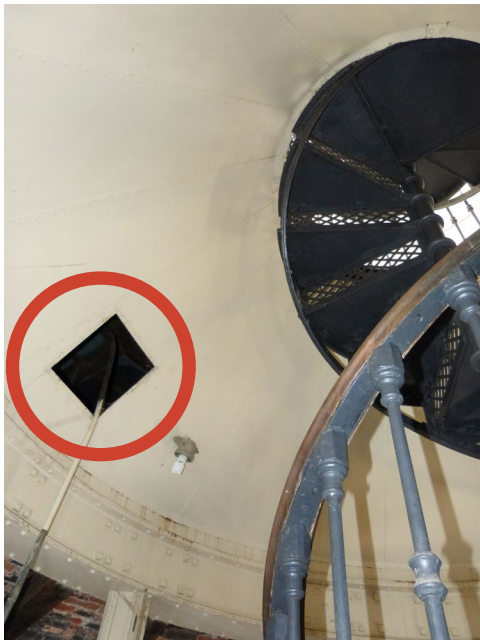
The lantern attic is an enclosed ring between the lantern observation deck and the main dome structure. This attic space is separated from the main dome interior by metal panels and is accessible only through a small opening in the panels (requires a ladder, which we borrowed from DAS) (Photo 12). We note the following observations relevant to our work:

There is no hatch door or closure to cover the opening between this attic and the main dome (Photo 12). When accessing the attic, we typically noticed strong airflow into the attic from the main dome area. We saw no provisions for ventilating this space to the exterior, but we saw daylight through the roof assembly, indicating numerous small air leakage paths.

**Photo 12** Spiral stair leading up to lantern and access hatch leading into lantern attic.

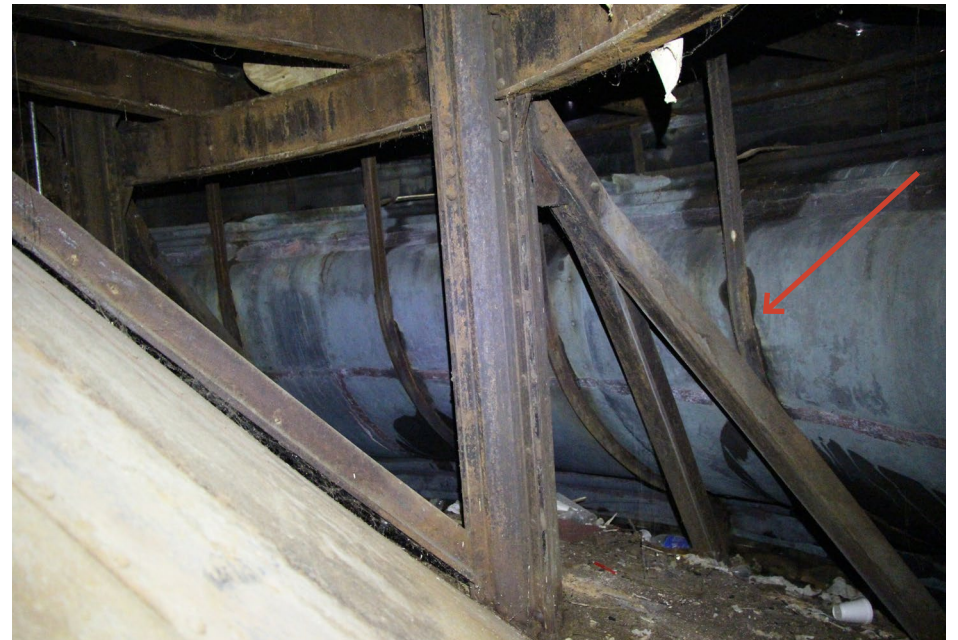
- Similar to the lantern dome roof, the back side of the metal cladding enclosing this space is visible and there is no backup substrate or waterproofing behind the metal cladding (Photo 13). In this attic space, the sheet metal is typically mechanically anchored to the metal straps connected to the metal structure.

Eight cast-iron columns extend above the dome compression ring to form the structure of the lantern (Photo 13). Cantilevered radial floor beams form the structure of the mid lantern landing. A portion of this landing extends beyond the lantern walls to form the exterior lantern walkway. The lantern columns continue up to support the upper lantern observation level. Curved and radial floor beams frame the upper lantern floor. The lantern columns extend up to a braced compression ring at the bottom of the lantern dome. Access from the lower lantern floor to the mid and upper lantern floor is provided by a spiral staircase (Photo 19). Walls above the mid lantern floor are constructed with wood.

**Photo 13** Metal framing & backside of sheet metal cladding (arrow) within the lantern attic.

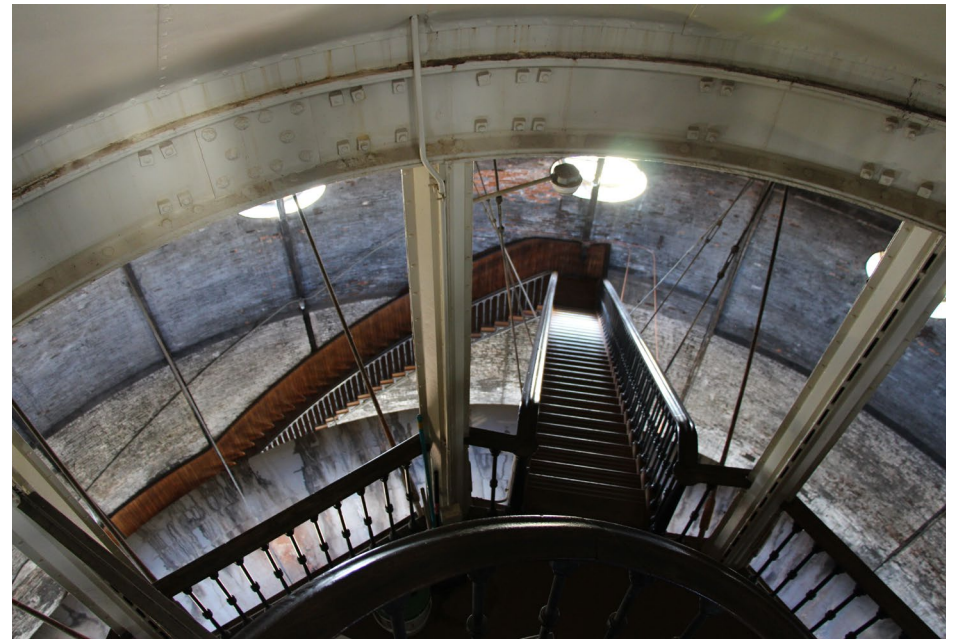
The main dome is constructed with 24 12-inch-deep wide flange metal ribs extending vertically from the base of the dome (bottom of Level K) up to a compression ring at the base of the lantern (Photos 19 and 20). The ribs are recessed into the brick masonry of the dome. At the circular windows, a ½-inch thick circumferential strap is riveted to the exterior side of the wide flange ribs (Photo 20). No additional circumferential bracing is visible from the interior. The skydome, stairs, and lantern access platform are all supported via tie rods attached to the dome’s metal frame (Photos 19 through 21).

The dome is supported by 24 cast-iron radial ribs that span vertically along the dome from the 3-wythe masonry wall located 8 feet, 4 inches below the dome spring line, to the circular cast-iron compression ring approximately 48 feet above (Photo 19, 21). Flat masonry arches span between cast-iron ribs. Masonry on the lower portions of the dome (longer span) consists of 3-wythes of masonry and transition to a single wythe of masonry at the top (Photo 20). Hangers extend down from the cast-iron compression ring to support the lower lantern landing. Lateral ties extend from each hanger to the radial ribs, to stabilize the landing (Photo 21). Access to this landing is provided by a cast-iron stair that follows along the perimeter of the dome and crosses above the interior suspended dome to the lower landing. All cast-iron connections are either riveted or bolted. Flat masonry arches are supported on the flange of the radial ribs by continuous wood sleepers (Photo 23).

**Photo 21** Platform and stair access viewed from base of lantern.

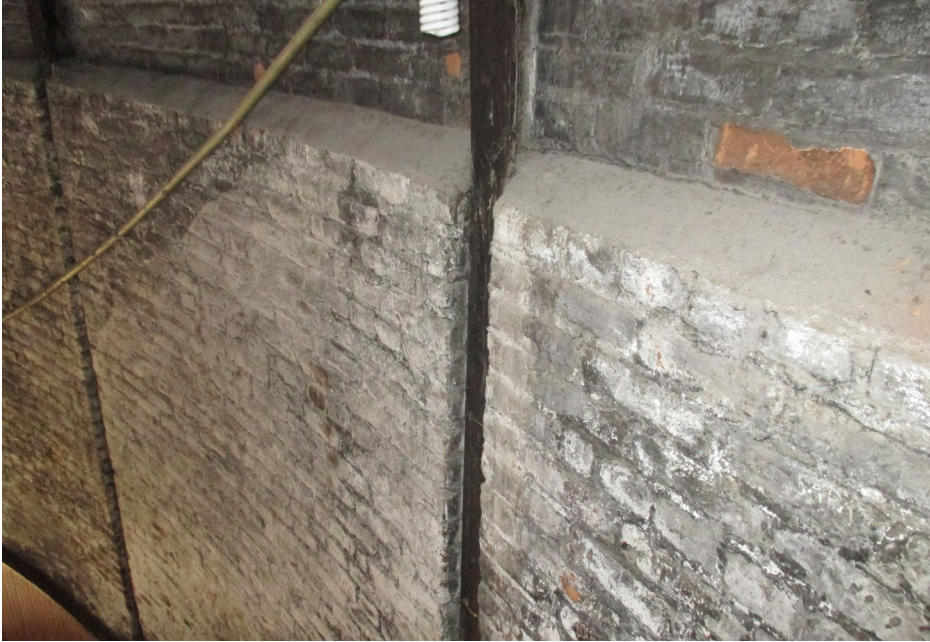
The exterior dome consists of a brick masonry shell that spans between the metal ribs in a running bond pattern. The masonry is one wythe thick at the top (as measured at hole noted in previous section) and visibly steps out to a thickness of two and then three wythes at the lower portions of the dome (Photos 20 and 22). Wood blocking is installed around the wide flange web at the single-wythe areas (Photo 23), presumably to support the masonry termination and shoring during the original construction where it abuts the wide flange web.

**Photo 22** Brick shell's step from two to three wythes.

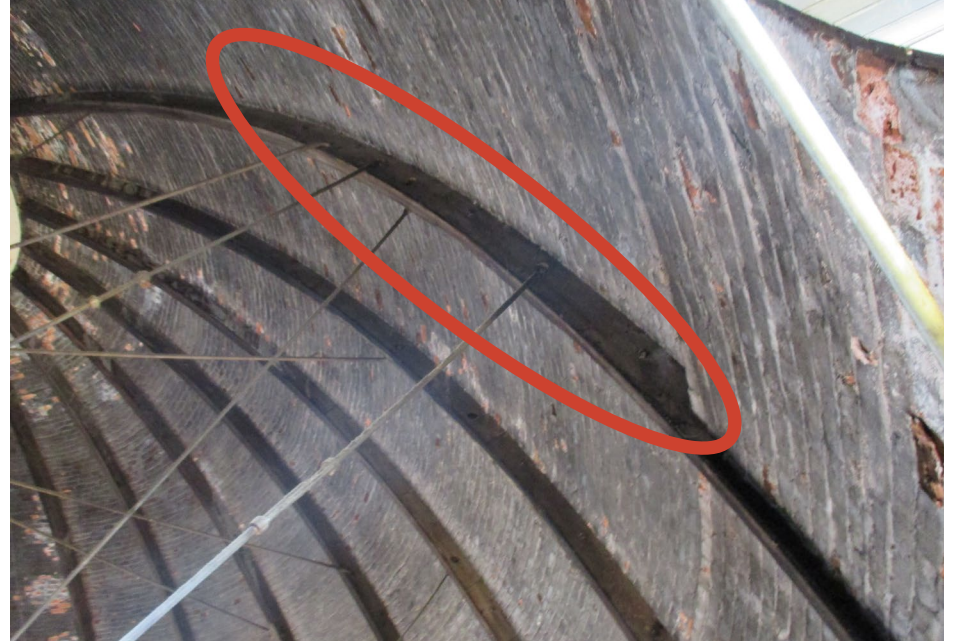
**Photo 23** Brick shell and ribs; note wood blocking through-bolted to rib webs at upper single-wythe shell area.

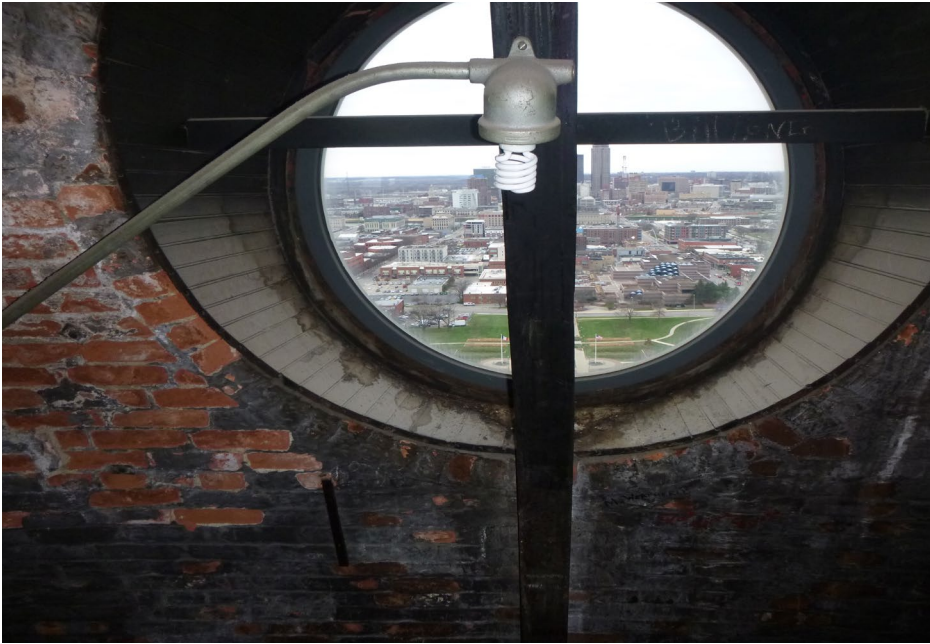
**Photo 30** Typical dome window interior.

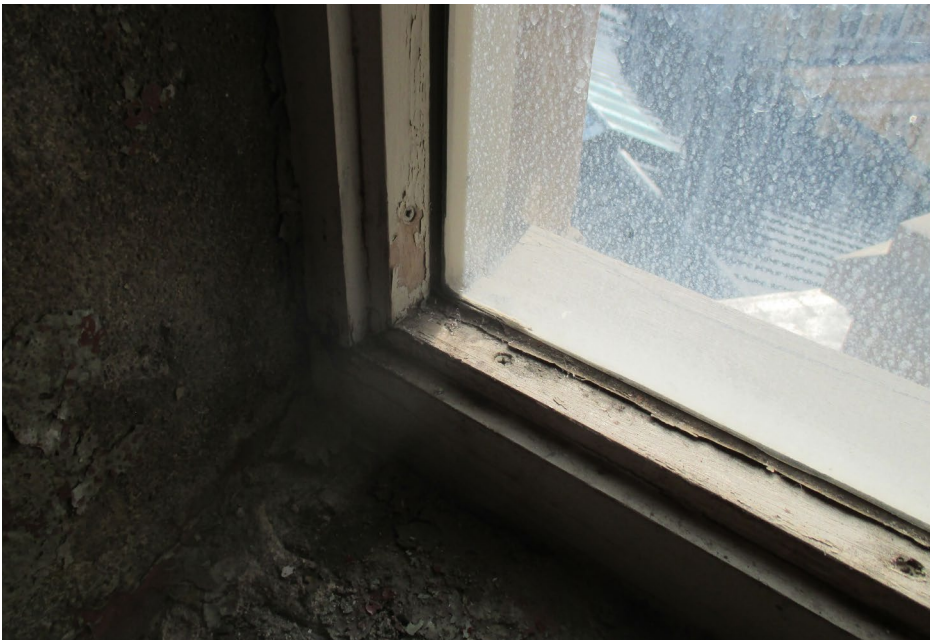
- The spiral stairway leading up to the dome (Level H) has several rectangular round top wood windows. Wood components are aged and water stained (Photo 32).

**Photo 32** Wood-framed window within spiral staircase access up to dome attic.

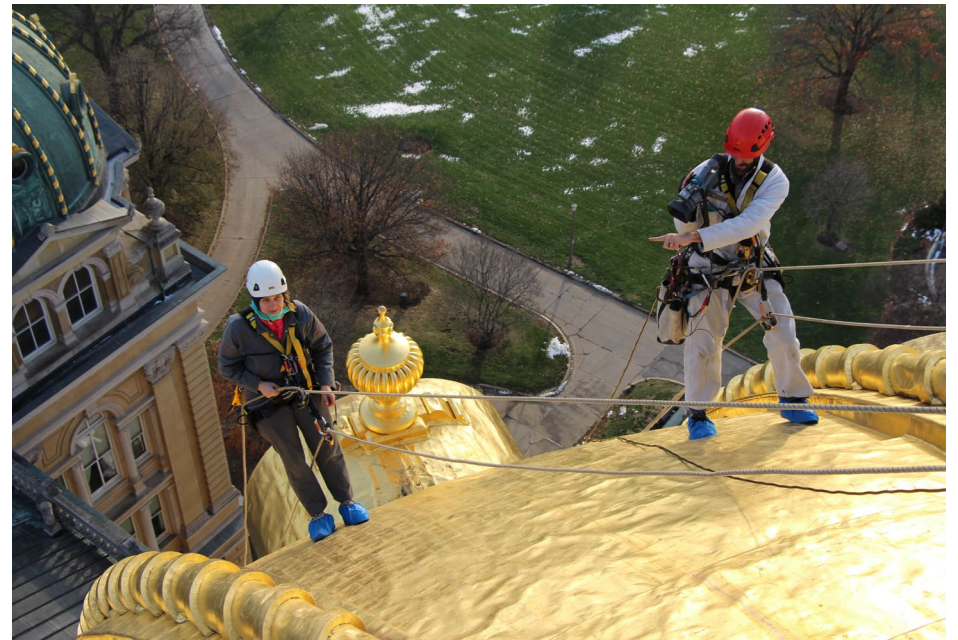
With assistance from Vertical Access LLC (VA), Simpson Gumpertz & Heger (SGH) performed a hands-on survey of the dome roof using industrial rope access (Photo 33). We also inspected the upper portions of the lantern using video documentation with a pole-mounted high definition camera.

**Photo 33** Industrial rope access used for exterior inspection.

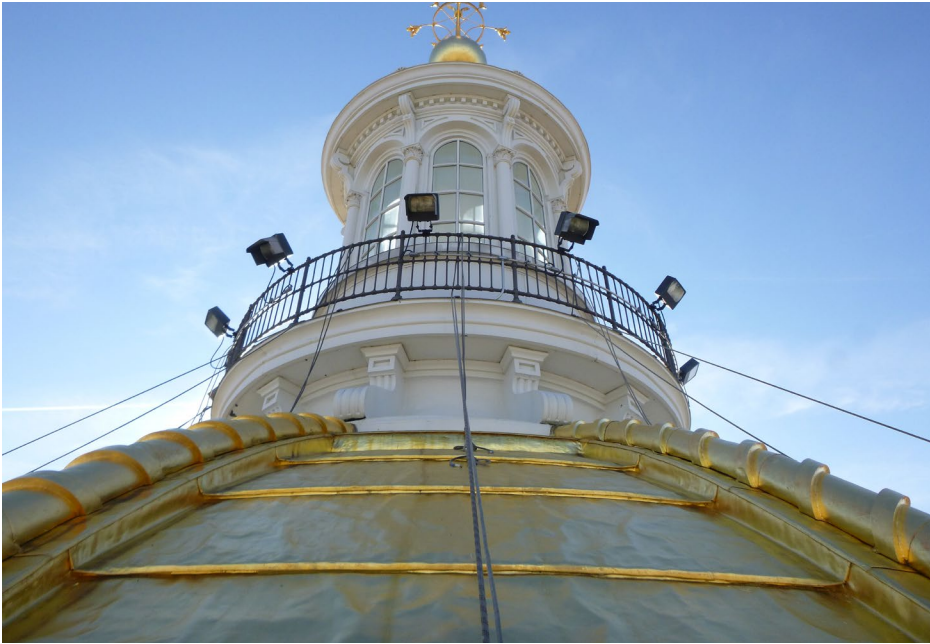
**Photo 34** Lantern exterior.

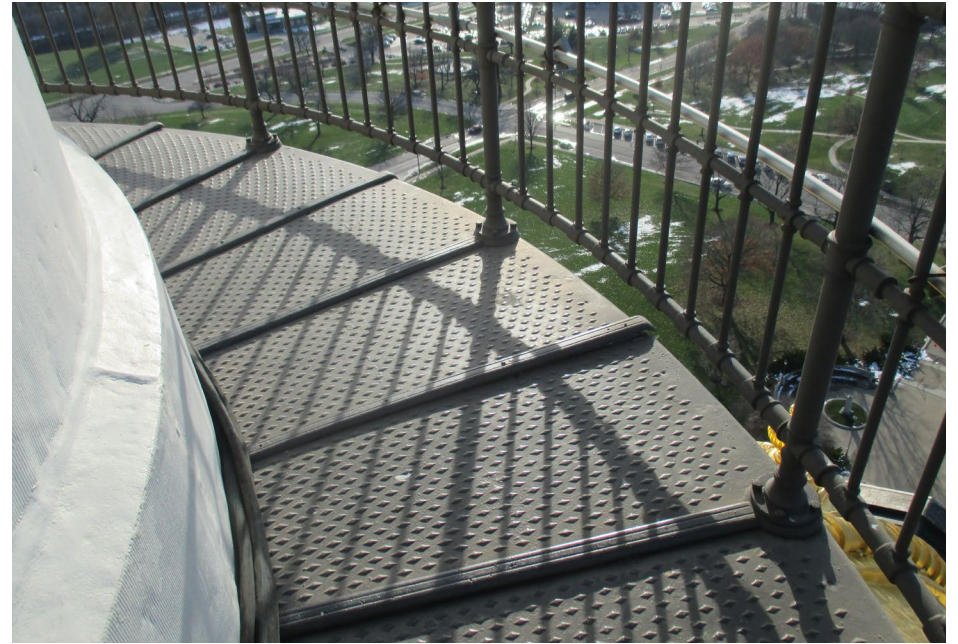
- Address bulk leakage at observation deck at the lantern level, the primary area that is causing damage to the masonry dome below. The source of the leakage is the observation deck planks and guardrail connections.

**Photo 35** Observation deck planks, covers, and guardrail.

- Solution: Provide plywood or heavy gauge sheet metal deck covered with continuous roof membrane under the observation metal deck planks. Repair the damaged masonry at the top of the dome with a new working platform.

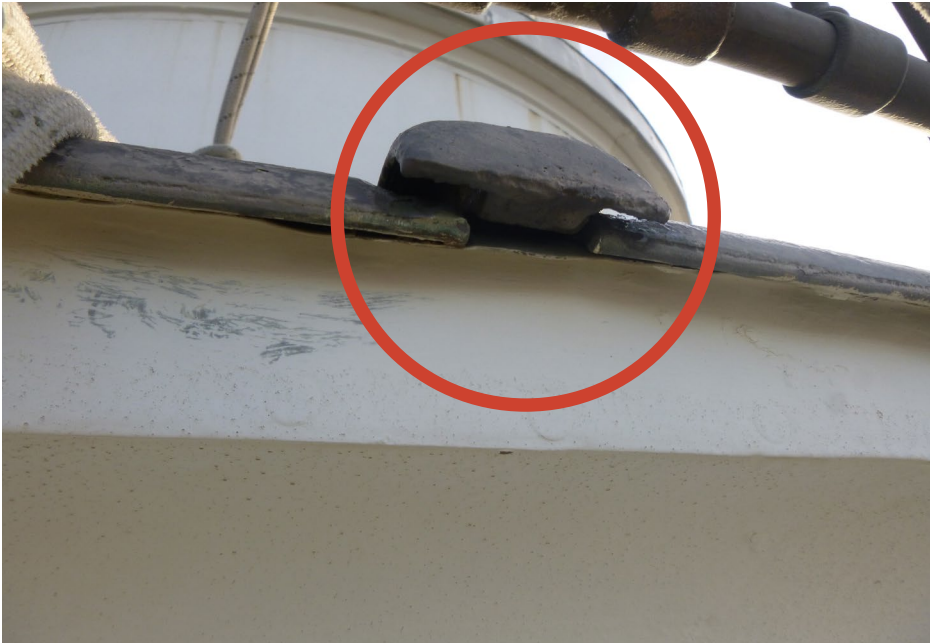
**Photo 38** Edge of observation deck plank has limited overlap onto cladding below; note gap at end of cover.

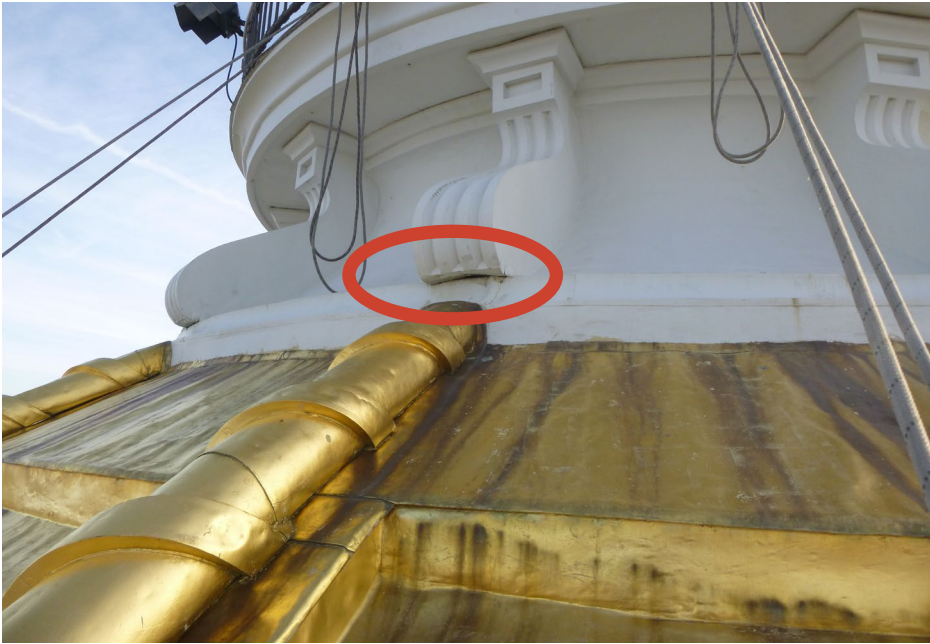
**Photo 42** Lantern skirt and typical decorative sheet metal bracket.

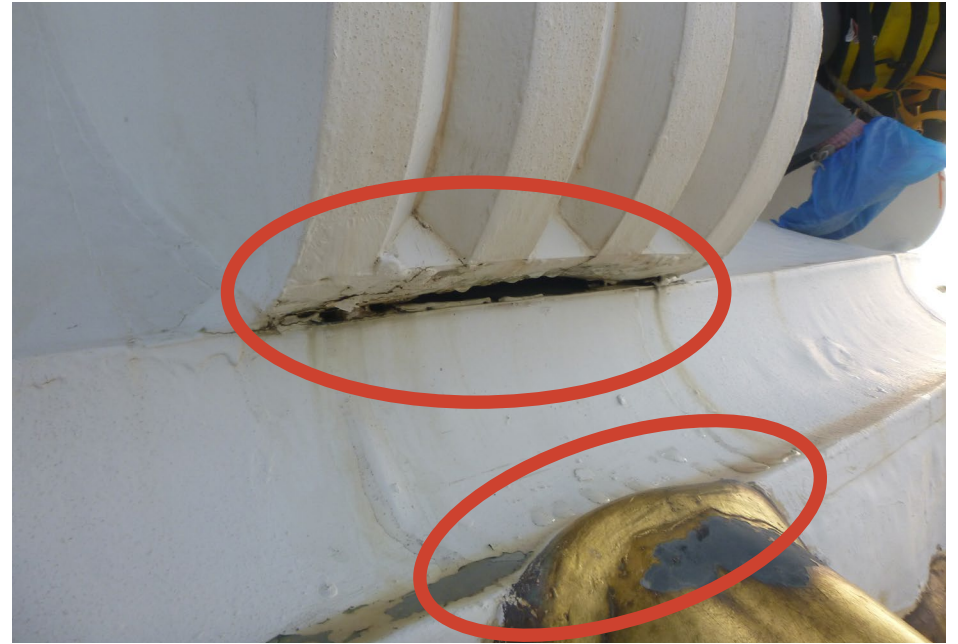
**Photo 43** Typical gap at base of bracket; note water on cladding below (several days after any rain/snow).

- Perform waterproofing repairs to copper sheet metal to address direct leakage paths in the lantern cladding, dome and stylobate level.
  - Solution: Repair openings at the base of the brackets, repair holes and penetrations in the cladding, repair copper entablature roofing above the upper cornice and open joints in the flat lock copper on the stylobate level.

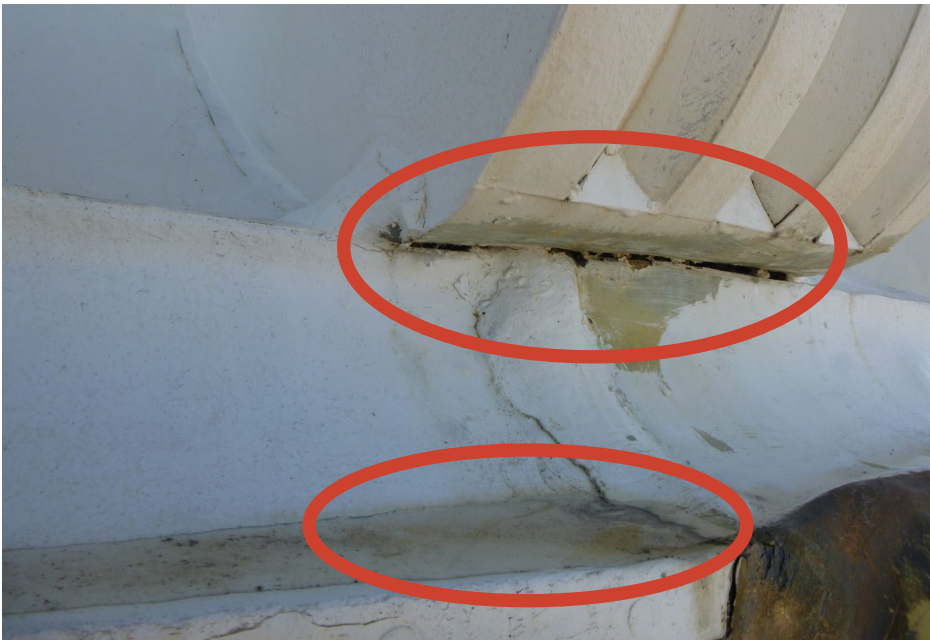
**Photo 44** Typical gap at base of bracket and water on cladding below (several days after any rain/snow).

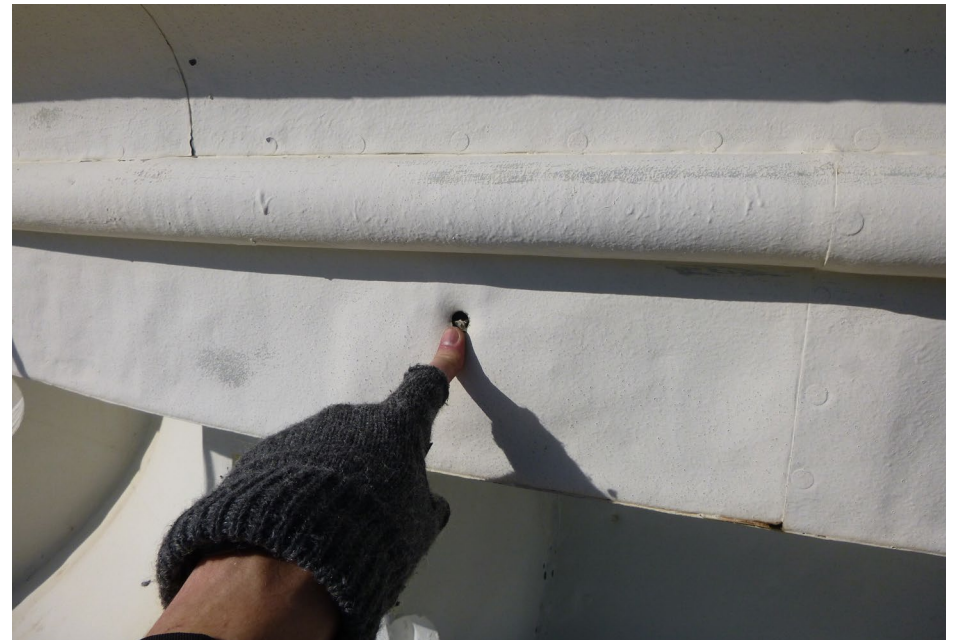
- We noted several isolated holes (Photo 45) and fastener heads where the coating had separated (Photos 46 and 47) in the painted metal cladding.
- The coating obscures most seams and anchor penetrations in the lantern skirt, but other than the conditions noted above, we saw no obvious damage or deterioration on the lantern skirt's sheet metal cladding.

**Photo 45** Hole in cladding directly below observation deck.

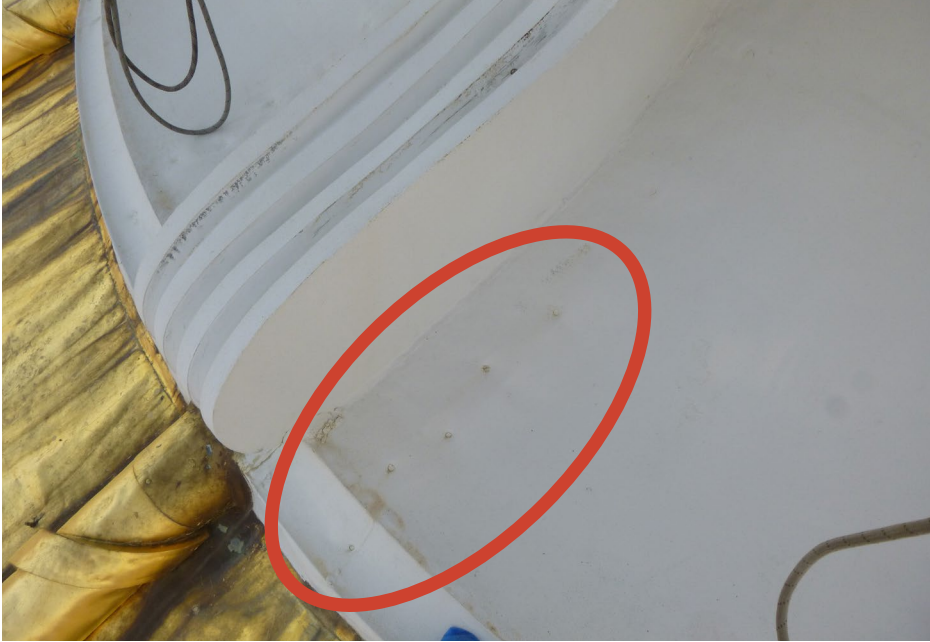
**Photo 46** Fastener heads visible through coating.

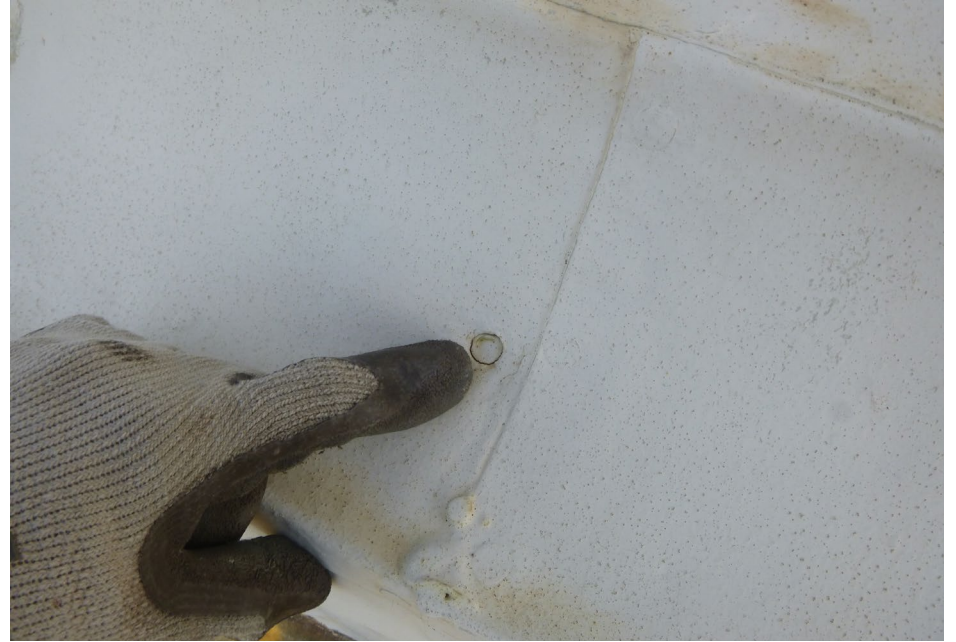
**Photo 47** Closer view of one fastener head shown in previous photo.

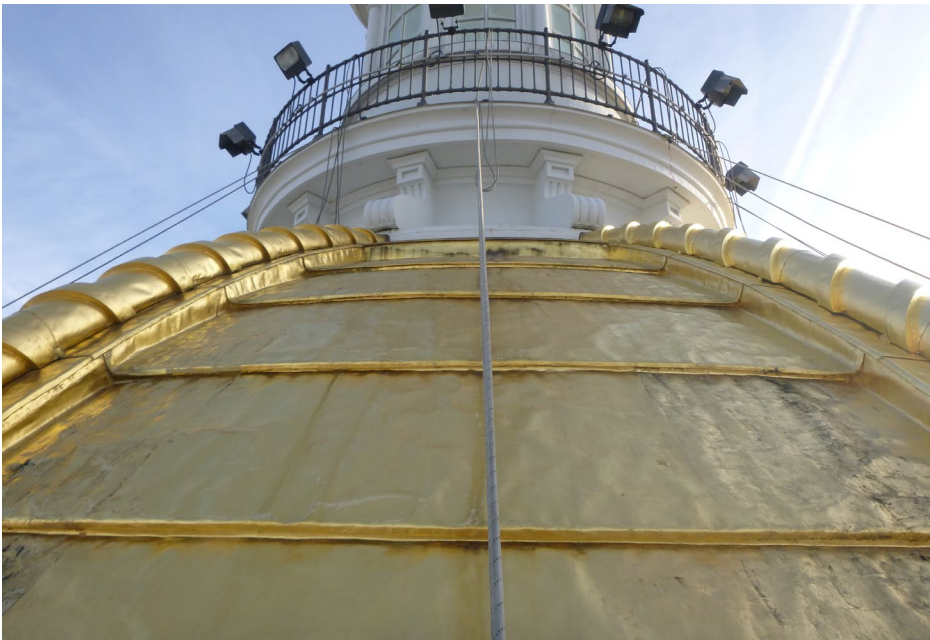
- The dome roofing consists of continuous sheets of copper running circumferentially between twelve raised ribs. Individual copper sheets are separated by stepped horizontal lock joints (Photo 48). Vertical ribs are covered with a continuous cap flashing and a decorative coil (Photo 49). All metal roofing, flashing, and decorative metal is gilded.

**Photo 48** Typical gilded dome roofing.

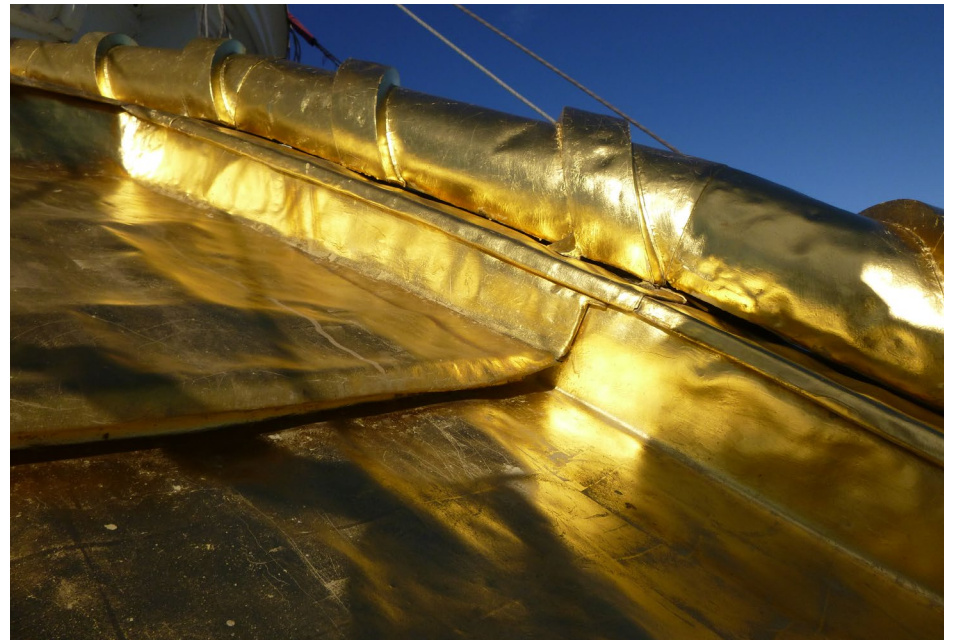
**Photo 49** Decorative coil at ribs; note coil sits above a continuous rib flashing.

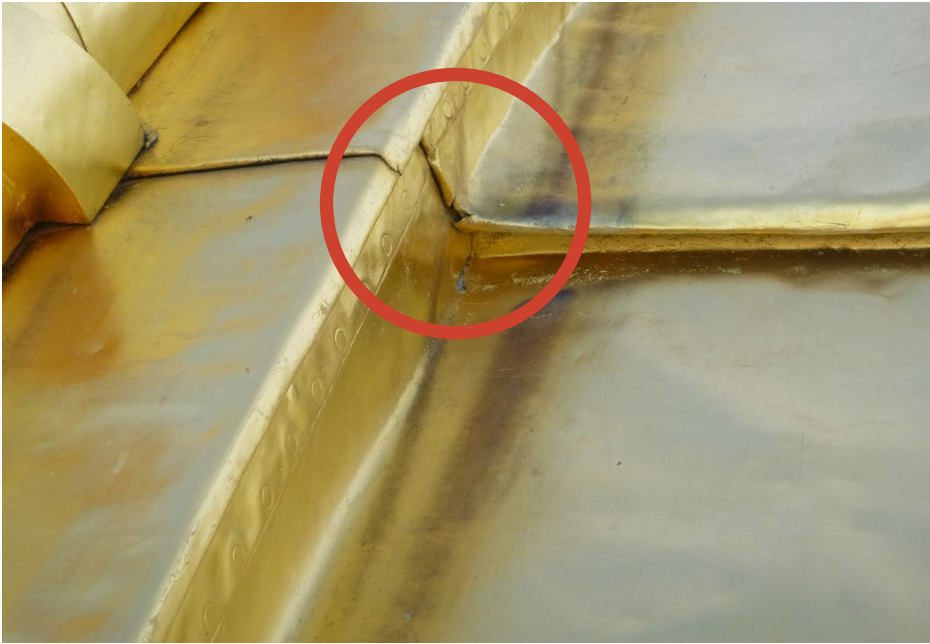
- Roofing sheets, lock joints, and rib flashing are typically intact. We observed isolated splits where the sheet turns up at ribs (Photo 50), oil-canned or buckled sheets (Photo 51), and isolated sheet metal repair patches (Photo 52).

**Photo 50** Split sheet metal and pinhole at typical stepped roofing sheet's transition to rib.

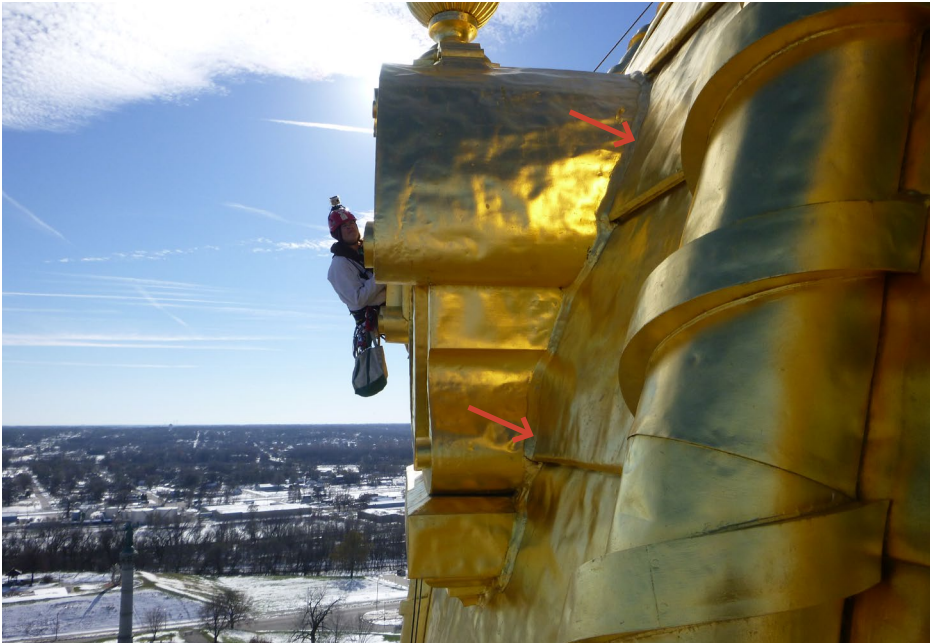
**Photo 54** Typical dome eyebrow dormer viewed from the side; note continuous lead fillet along eyebrow transition to roof.

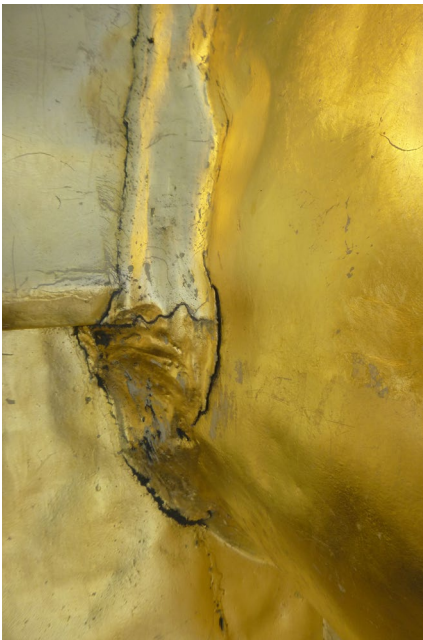
**Photo 56** Splits and separation of typical lead fillet at eyebrow dormer.

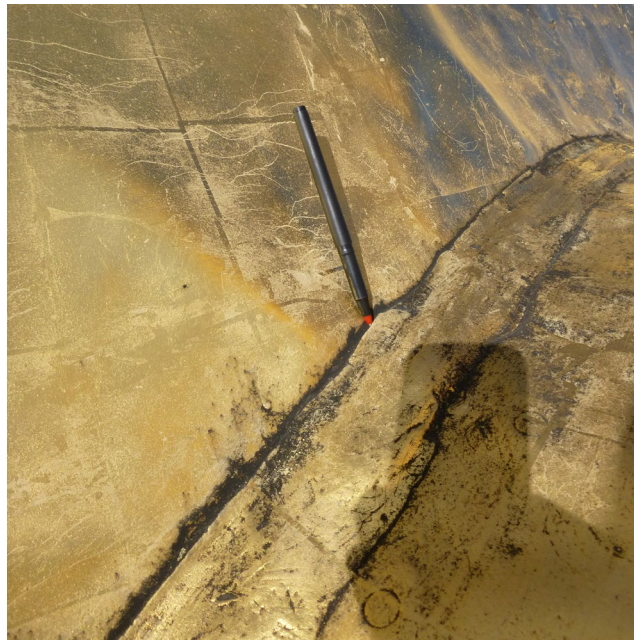
**Photo 57** Separation of lead fillet at eyebrow dormer head.

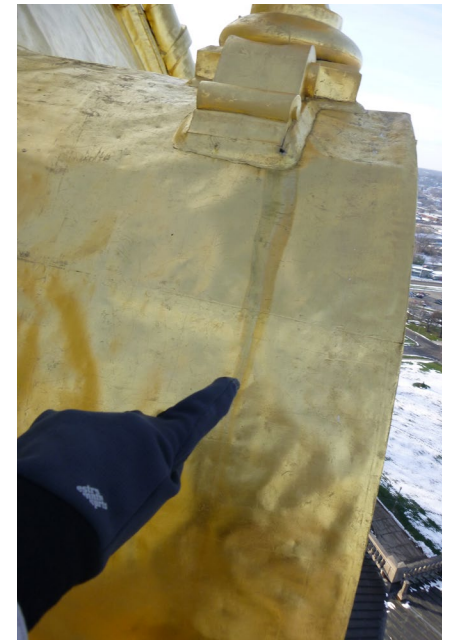
**Photo 58** Water stains at hole in lead fillet at eyebrow dormer finial.

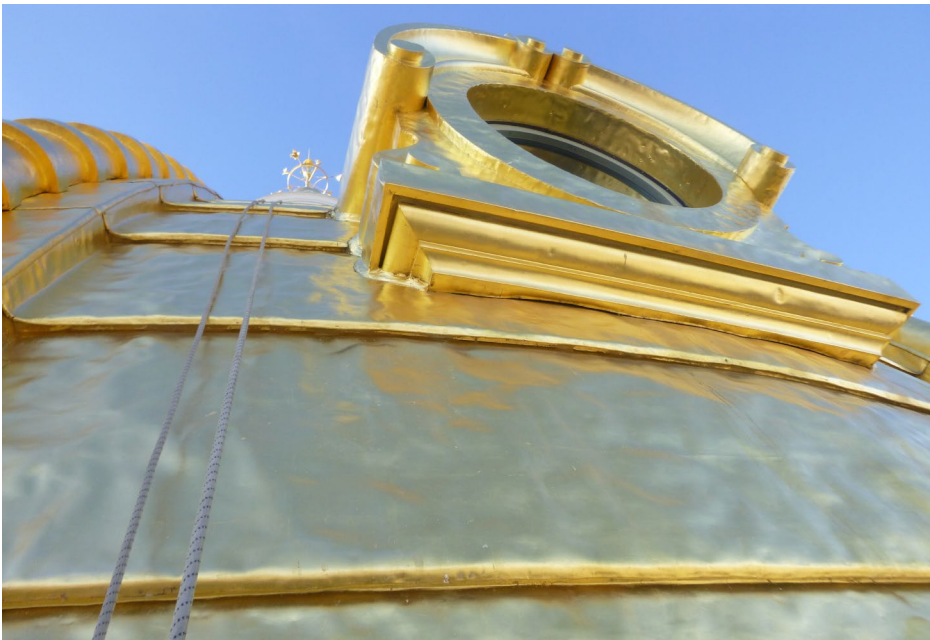
**Photo 61** Typical dome eyebrow dormer viewed from below.

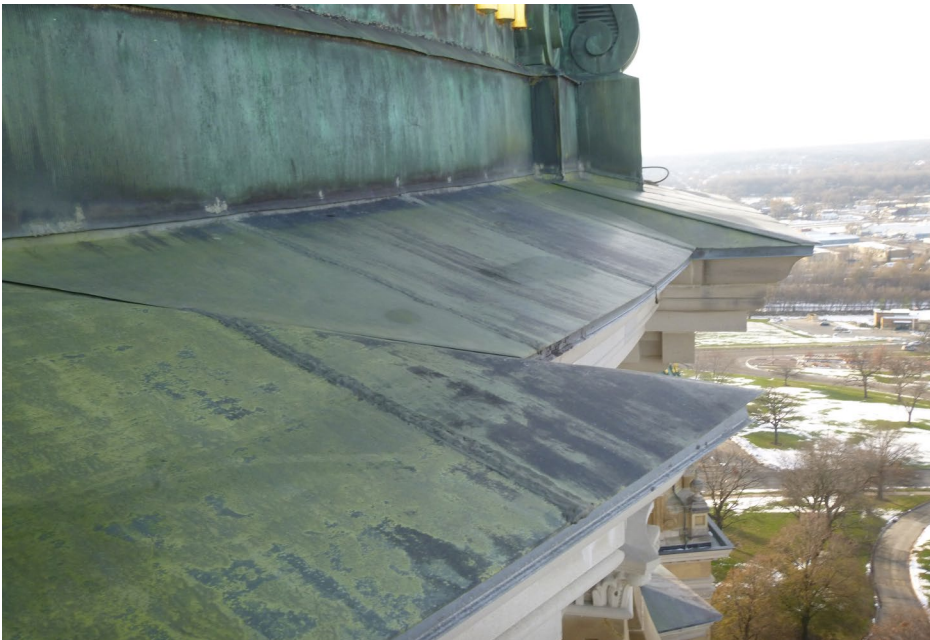
- At the base of the gilded dome, the masonry drum that supports the dome is ringed by a copper-clad entablature and projecting masonry cornice with a lead-coated copper cornice flashing (Photo 65). The copper cladding on the entablature is typically intact. Non-skyward-facing joints are typically not soldered watertight (Photo 66). Skyward-facing joints are typically soldered, though many of these joint are cracked (Photo 67). We did not see any expansion joints in the soldered portions of the entablature.

**Photo 65** Copper-covered upper cornice at base of dome.

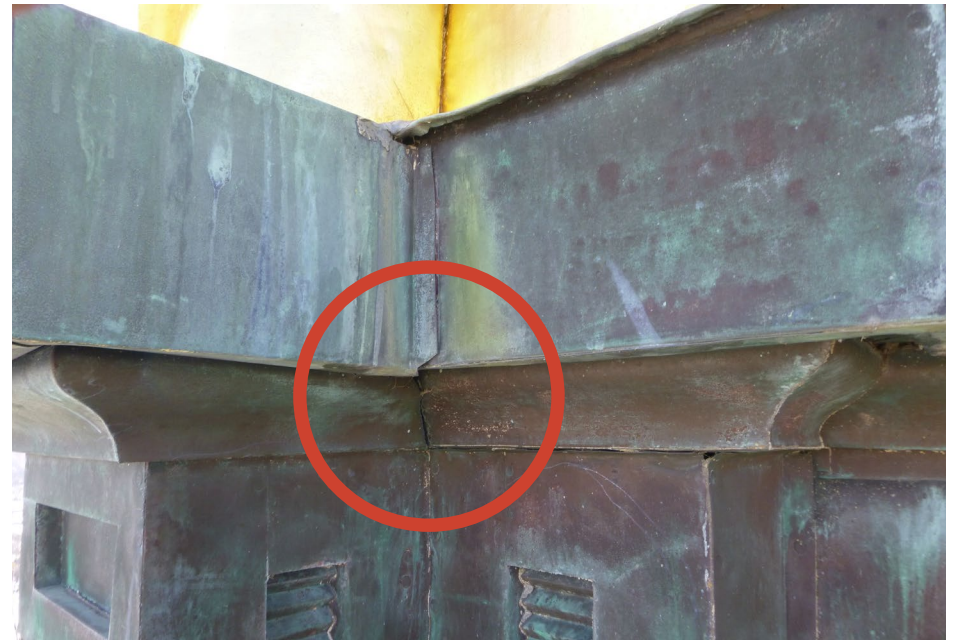
**Photo 66** Typical open seams in non-skyward-facing joints of copper entablature at base of dome.

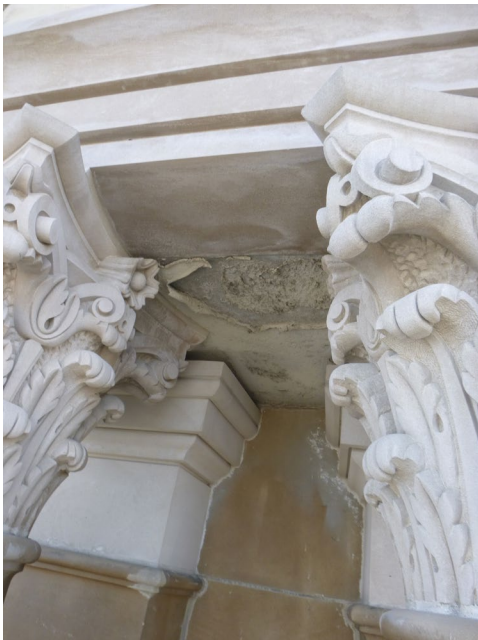
- The stone soffit above stone columns at Level H is typically water stained and exfoliating (Photo 73).
  - We observed isolated cracks, epoxied stone repairs (e.g., stone dutchman), and surface deterioration at sandstone areas (Photos 74 and 75).

**Photo 73** Exfoliation at stone soffit below lower cornice and behind pair columns.

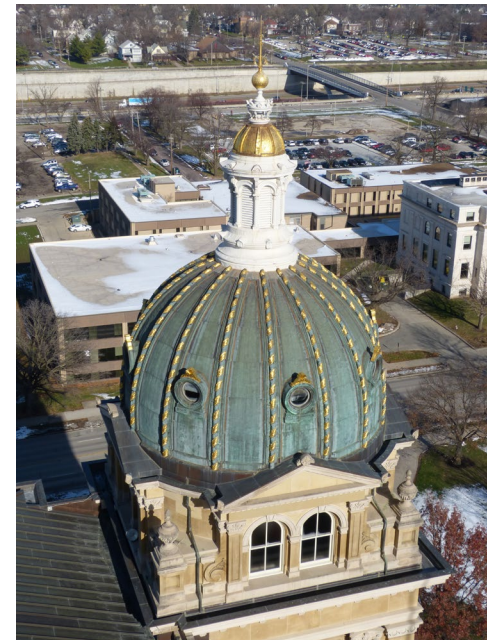
Our scope did not include the four smaller corner domes (Photo 78), but we noted from the exterior that the roof construction of these domes appears similar to the main dome. SGH and OPN also accessed the southeast and southwest dome attics to observe their interior construction. The small domes, appear constructed similarly to the main dome with wide-flange metal ribs, brick masonry vaults, circular eyebrow dormer windows, and lanterns. We did not have hands-on access to the dome masonry, but from the attic floor, we noted that small domes appear to have similar, but less severe, brick deterioration below the lantern and around windows as the main dome (Photo 79).

**Photo 78** Typical small dome.

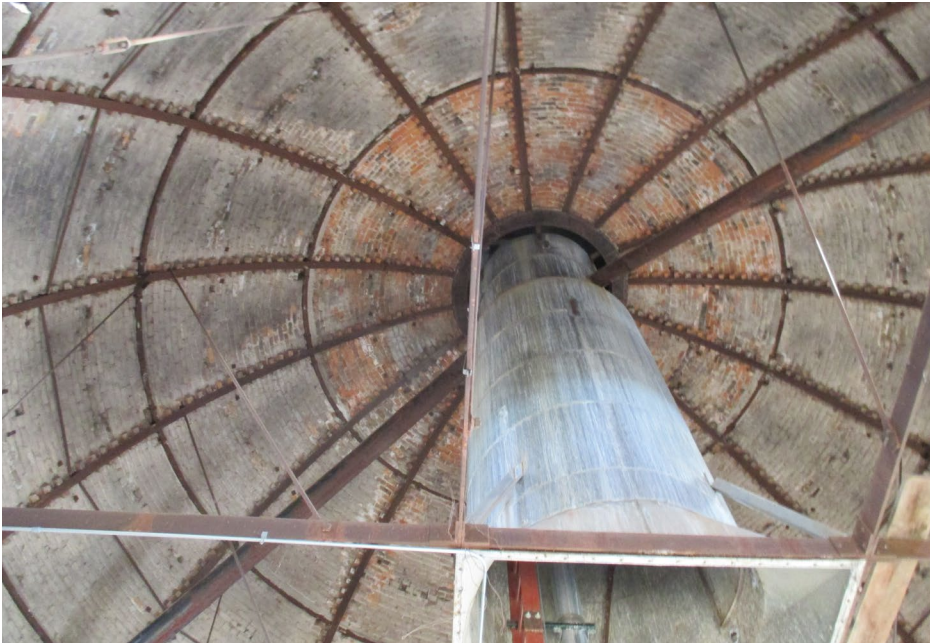
**Photo 79** Interior of southwest minor dome.
