## CAPITOL DOME STUDY FOR THE STATE OF IOWA

OPN Architects, Inc. + Simpson Gumpertz & Heger Inc. + Vertical Access LLC + Shuck-Britson, Inc.

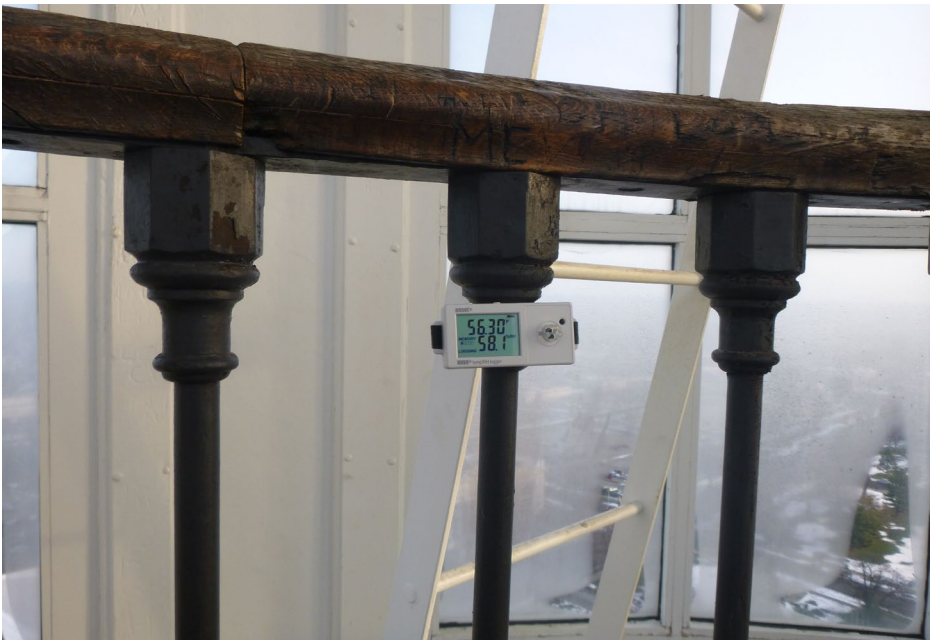
OPN installed temperature and relative humidity (RH) data loggers in the lantern (Photo 81), base of dome, drum (Level H), and exterior. On November 25, 2015, SGH also used these data loggers to take spot readings at representative interior spaces on the lower occupied floors. At the time of this report, we only have data from November 17 through December 10, 2015 (not through the colder winter months). We note the following from this initial data provided:

**Photo 81** Data logger in lantern (data noted is from November 24, 2015 at 8 a.m.).

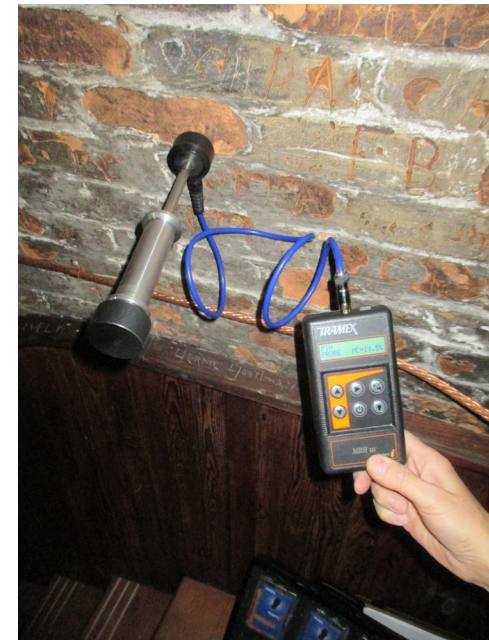
OPN and SGH used a Tramex MRH III moisture meter with 1 1/2 inch masonry pin probes to take representative moisture readings in the surface of the brick and at a depth of approximately 1 3/8 inch. (Photo 82). Individual moisture readings are not relevant and intended only as a comparison between intact brick and spalled/deteriorated locations. The moisture readings in damaged areas were nearly twice as high as the readings in the intact brick. We also note that the brick is relatively soft (both at intact and damaged locations) as we were able to fully insert the prongs of the testing probe into the brick using only the integral hammer/plunger on the probe handle.

**Photo 82** Brick moisture testing using a Tramex MRH III with 1 1/2-inch masonry pin probes.

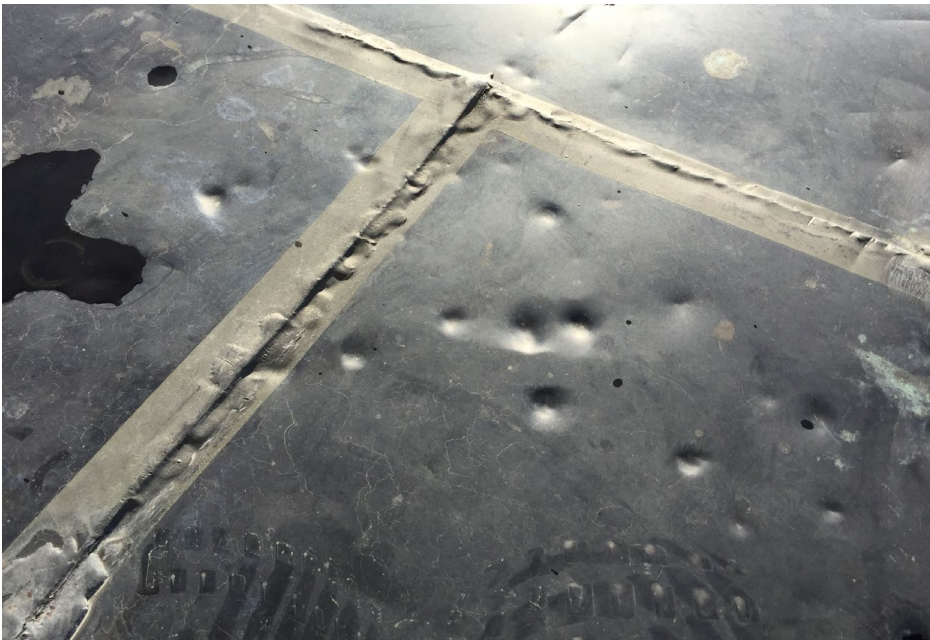
The stylobate flatlock copper is generally in good condition closer to the drum of the dome, and more bulk leakage and failures of the solder joints appear towards the edge of this level (Photo 83). The cause of the damage is the snow and ice falling from the main dome and breaking the solder joints (Photo 84, 85). The open joints allow the active water leaking into the building at the attic level and then to the both Chambers galleries below on the west. A number of the open joints were already indicted on the roof in pencil but have not been addressed. This will cause damage to the brick arch system and wood underlayment below the copper flatlock if allowed to continue.

**Photo 85** Stylobate level - Dented copper flatlock.
