# Cedar Lake Rehabilitation Project

Winterset Municipal Utilities  
Winterset, Iowa  
Madison County

## The Cedar Lake Rehabilitation Project

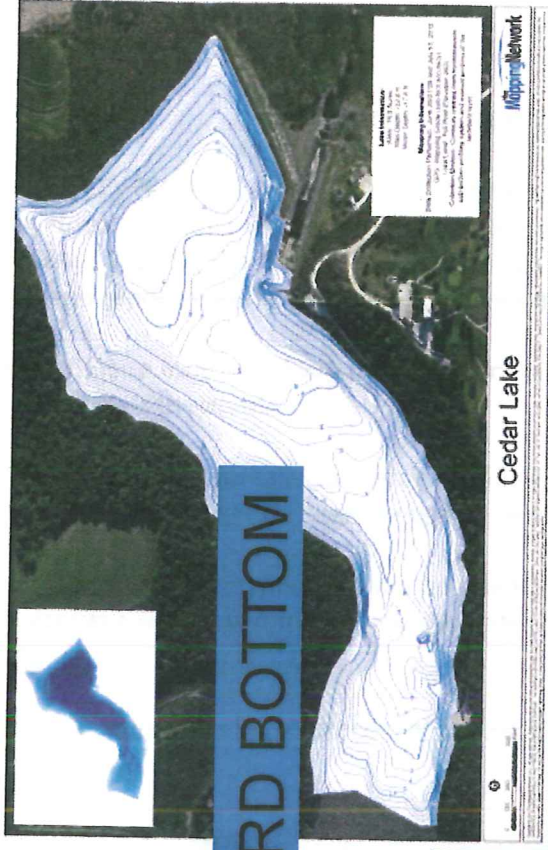
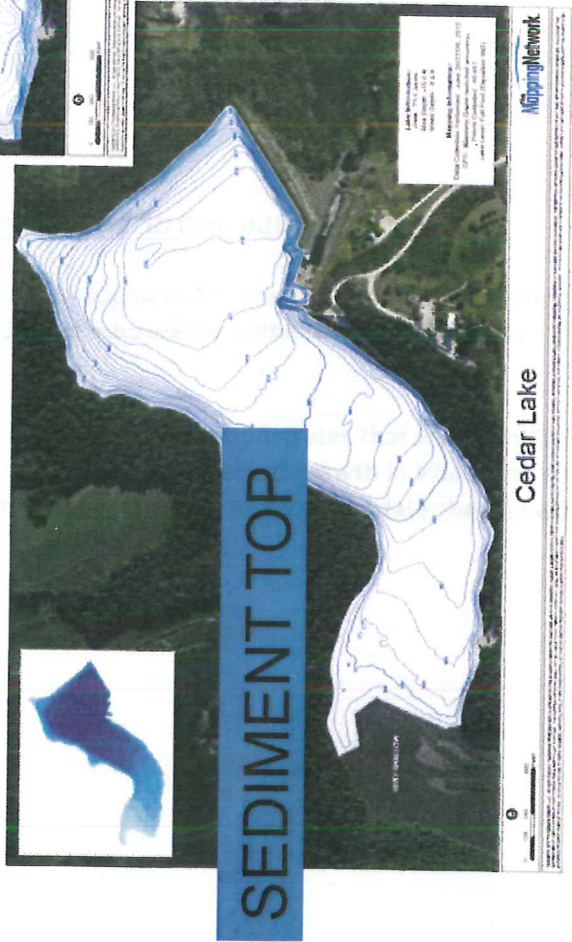
# DREDGE ANALYSIS

- Current water volume:
  - 1,166,000 CY
  - 235,431,000 gal
- Sediment volume:
  - 1,099,000 CY

- Potential water volume:
- 2,264,000 CY
  - 457,313,000 gal
