Lake Darling

A snapshot of success

How one Iowa lake is making real progress

A publication of the
Iowa Department of
Natural Resources
2006

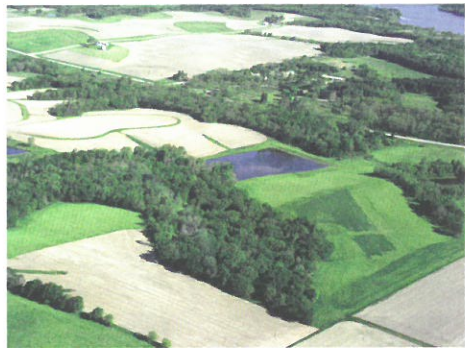
Photo courtesy Washington Co. SWCD
An erosion pond on Craig Wright's farm helps trap sediment.

Erosion control ponds

The ponds trap an estimated 95 percent of sediment from their drainage area. They also add recreational, wildlife and aesthetic benefits to landowners. Many of

these ponds were constructed along county roads and within the state park.

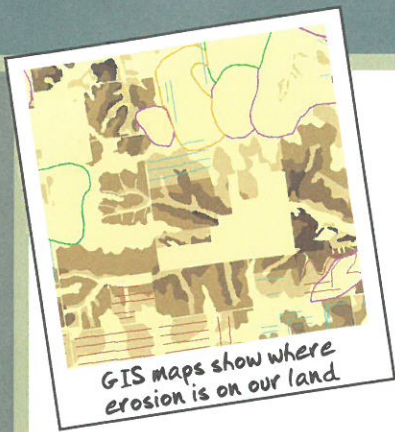
Above: A LiDAR map shows the elevation of the Lake Darling watershed, as well as conservation practices around the lake. LiDAR can be used to plan conservation practices for landowners.

LiDAR offers accuracy

A new technology called LiDAR— or Light Detection and Ranging— is an interactive topographic map with elevation data accurate within eight inches of actual elevations. The current statewide data has an accuracy of plus or minus five feet. LiDAR is a process of scanning the earth with lasers from an aircraft to obtain accurate elevations. It is similar to sonar in that it measures distance by the time it takes for the laser to reach the ground and bounce back to the aircraft.

LiDAR has been used to map the Lake Darling watershed, and the DNR hopes to expand the mapping statewide. LiDAR has many potential uses for landowners, including:

- Reduction of planning costs for soil conservation structures like terraces and sediment ponds
- Erosion potential measurements and modeling
- Floodplain and flood insurance mapping
- Permitting for animal feeding operations (floodplains and slope)
- Evaluating the performance of conservation practices

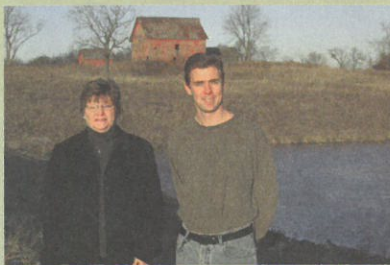
Landowner Dorothy Schultz and County Engineer David Patterson worked together to install this pond.

Partnerships made individual projects work as well. Dorothy Schultz is one Lake Darling landowner that worked with the watershed project and Washington County to build an erosion control pond.

After workers dug the hole for the pond, the excess dirt was used to build up the road and widen it, preparing it for future paving. The road serves as the dam for the pond, which filled with water naturally after rainfalls. Schultz gained a pond, the county has an improved road and the lake has less sediment washing into it.
